Damage of check dams by extreme rainstorms on the Chinese Loess Plateau: A case study in the Chabagou watershed

Y. Yang, S. Fu, B. Liu, B. Sun, C. Liu, Z. Wang, and S. Wu

Key words: check dams—damage—design standard—land use type—rainstorm—spillway

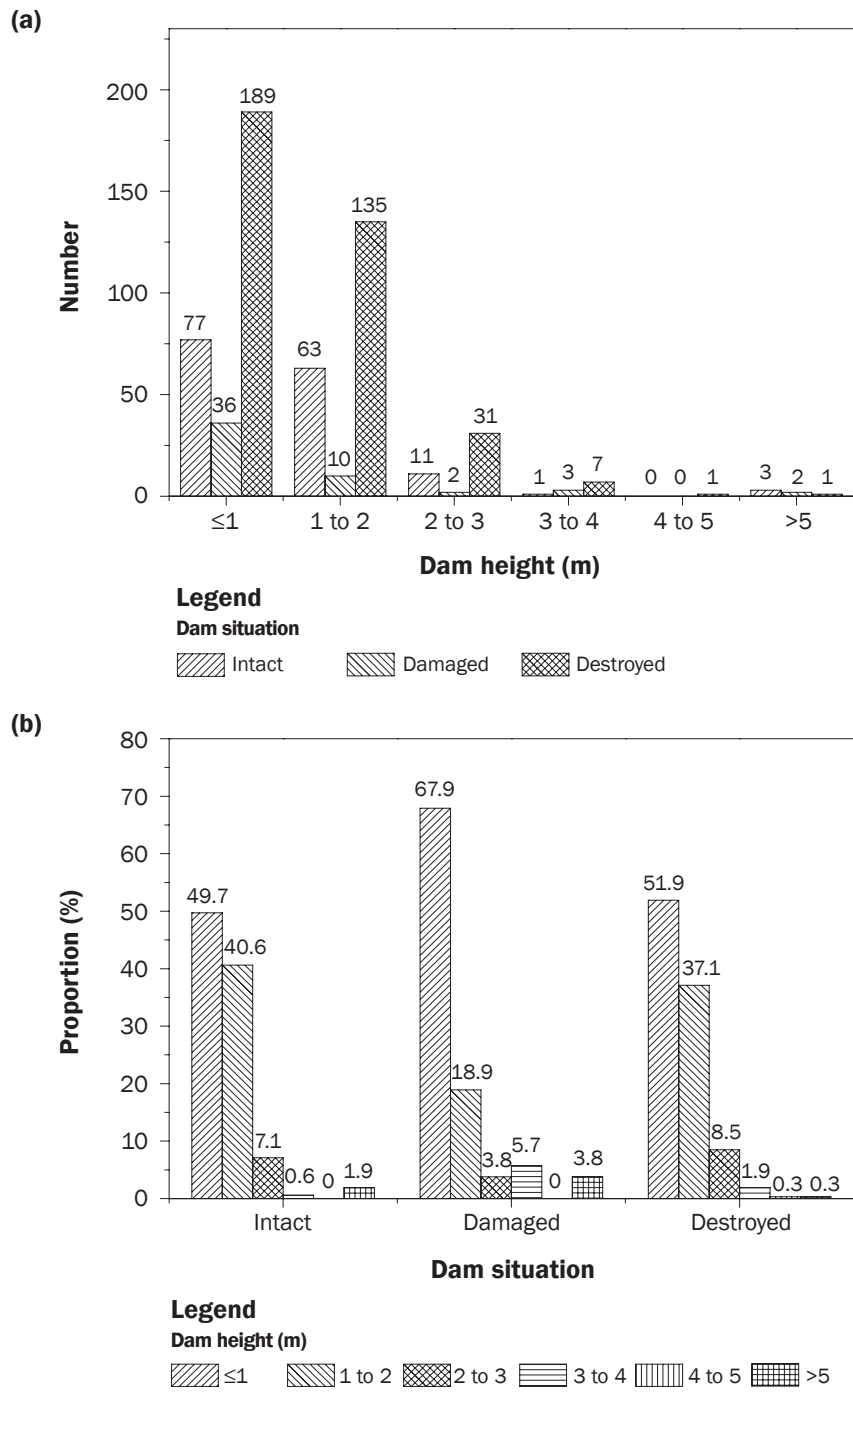
Damage to the Check Dams. As shown in figure 5, the numbers of intact, damaged, and destroyed dams were 155, 53, and 364, respectively, thus accounting for 27.1%, 9.3%, and 63.6% of the total. Check dams with heights of <1 m were the most likely to be damaged or destroyed, and accounted for 67.9% of damaged dams and 51.9% of destroyed dams. Moreover, 86.8% and 89.0% of damaged and destroyed dams, respectively, were <2 m in height. These results indicate that the majority of check dams were severely damaged by the “7.26” extreme rainstorm on July 25 and 26, 2017.

Figure 5
 (a) Number of check dams and (b) proportion of check dams in intact, damaged, and destroyed situation as classified by dam height.
