# Damage of check dams by extreme rainstorms on the Chinese Loess Plateau: A case study in the Chabagou watershed

Y. Yang, S. Fu, B. Liu, B. Sun, C. Liu, Z. Wang, and S. Wu

**Key words:** check dams—damage—design standard—land use type—rainstorm—spillway

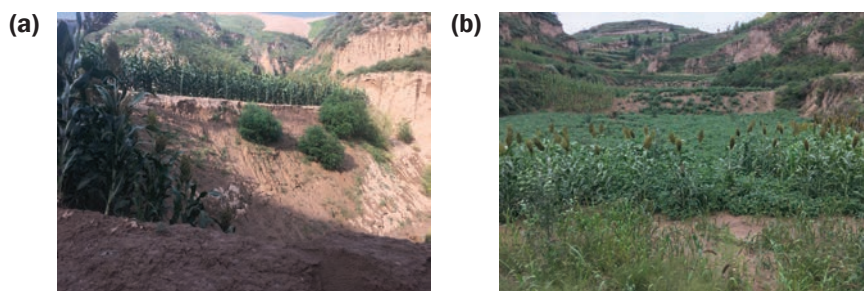
**Figure 2**

Check dams in study area. (a) A dam built with soil, and (b) silt-up dam land.

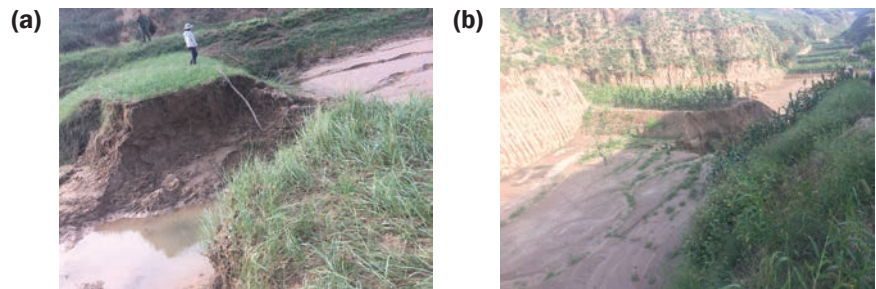
### Figure 3

The check dams were destroyed in the manner of openings or culverts, as shown in table 3. The openings in the dam bodies ranged from 0.6 m to 23.3 m wide (mean of 4.8 m) and from 0.4 m to 14.8 m in depth (mean of 3.4 m). The widths of the culverts were between 0.3 m and 7.2 m (mean of 1.7 m), while their depths ranged between 0.4 m and 5.5 m (mean of 2 m). The majority of the dams that were destroyed by openings

were <4 m in height, while the majority dams that were destroyed by culverts were <3 m in height.

Destroyed check dams during the “7.26” rainstorm. A destroyed dam indicates that the flood waters created an opening or culvert in the dam body, which allowed water to move from the upstream to the downstream of the dam. (a) An opening on a dam body across a stream, and (b) an opening on a dam body across silt-up dam land.

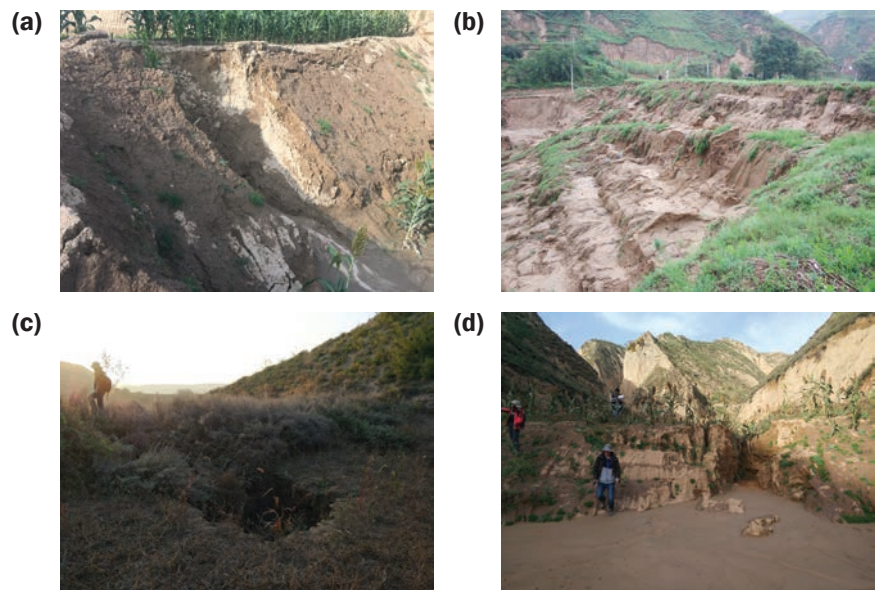
### Figure 4

Damaged check dams during the “7.26” rainstorm. A damaged dam indicates that the dam body was intact, but that rills developed on the upstream slope, downstream slope, or top of the dam. (a) Minor damage on the upstream slope of a check dam; (b) severe erosion on the downstream slope of a check dam; (c) cave-in on the downstream slope of a check dam; (d) minor damage on the downstream slope of a check dam.

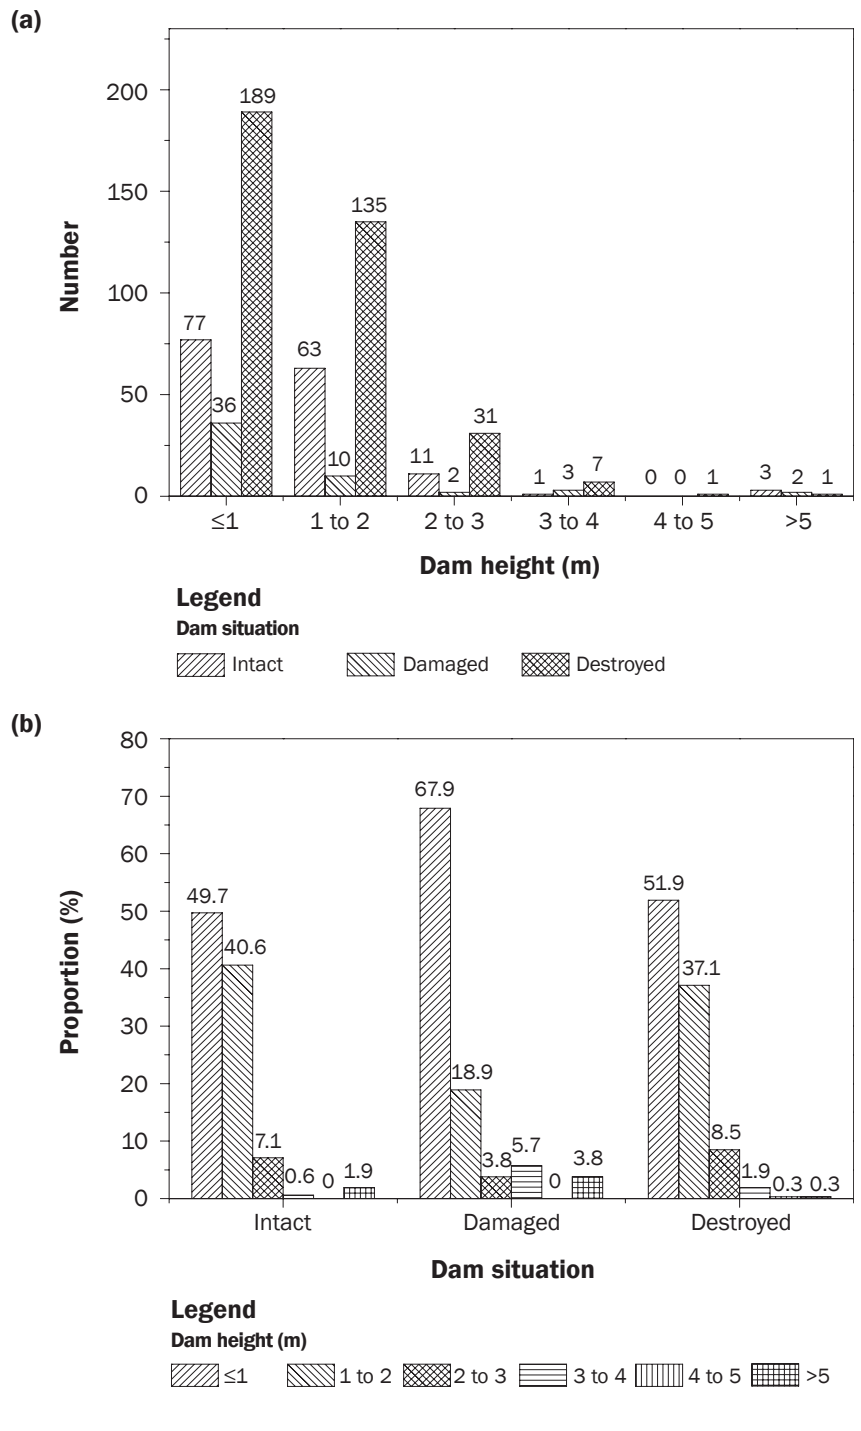
**Damage to the Check Dams.** As shown in figure 5, the numbers of intact, damaged, and destroyed dams were 155, 53, and 364, respectively, thus accounting for 27.1%, 9.3%, and 63.6% of the total. Check dams with heights of <1 m were the most likely to be damaged or destroyed, and accounted for 67.9% of damaged dams and 51.9% of destroyed dams. Moreover, 86.8% and 89.0% of damaged and destroyed dams, respectively, were <2 m in height. These results indicate that the majority of check dams were severely damaged by the “7.26” extreme rainstorm on July 25 and 26, 2017.

**Figure 5**  
 (a) Number of check dams and (b) proportion of check dams in intact, damaged, and destroyed situation as classified by dam height.

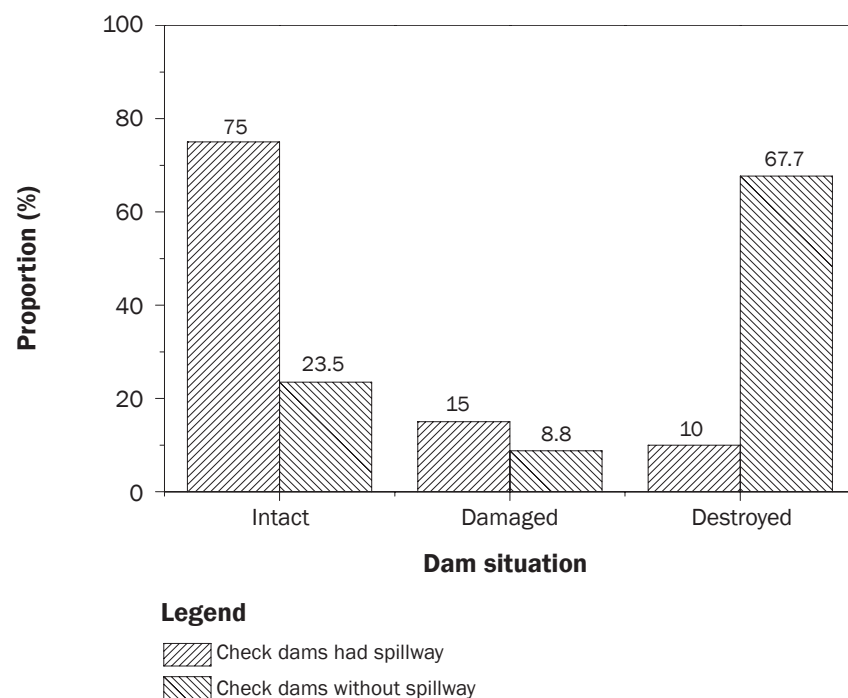
**Poor Drainage Capacity.** A spillway is a flood control accessory that is designed to drain flooded to downstream areas when the water level exceeds a dam's safety limit, thus protecting the dam from damage that could be caused by overflow. In this study, only 34 check dams had spillways (table 1), 75% of which remained intact, while only 15% were damaged and 10% were destroyed. However, for the check dams without spillways, 23.5% remained intact, 8.8% were damaged, and 67.7% were destroyed (figure 6). Hence, dams with spillways largely remained intact and suffered considerably less destruction during the rainstorm in comparison to those without spillways.

The investigation also revealed that 76.5% of spillways were man-made road. A small percentage included were openings in the dam bodies that had developed during pre-

vious floods and served as spillways in the "7.26" rainstorm. In some cases, the bottom of the spillway had become higher than the dam crest due to inadequate maintenance, and the spillway lost its ability to function as a means of flood discharge. Thus, the lack of a spillway and inadequate maintenance meant that flood waters were not discharged in time, which may have also been responsible for the damage caused to dams during the extreme rainstorm.

**Figure 6**  
Spillway and security of check dams.

significant effect on the lifespan and efficiency of the surveyed check dams. It can therefore be concluded that there is a need to increase the dam construction standard and build spillways. The design of spillways should take into account the proper type, size, and location of the cross-section as a means of ensuring that dams are not overtopped and do not collapse as a result of extreme rainstorms and floods. The silted sediment on spillways should be frequently cleared, especially before the rainy season, in order to ensure that flood water can be discharged in time to protect the dam body. In addition, drainage systems should be designed and built to form artificial flow paths as a means of enhancing the drainage function and protecting the silt-up dam land.

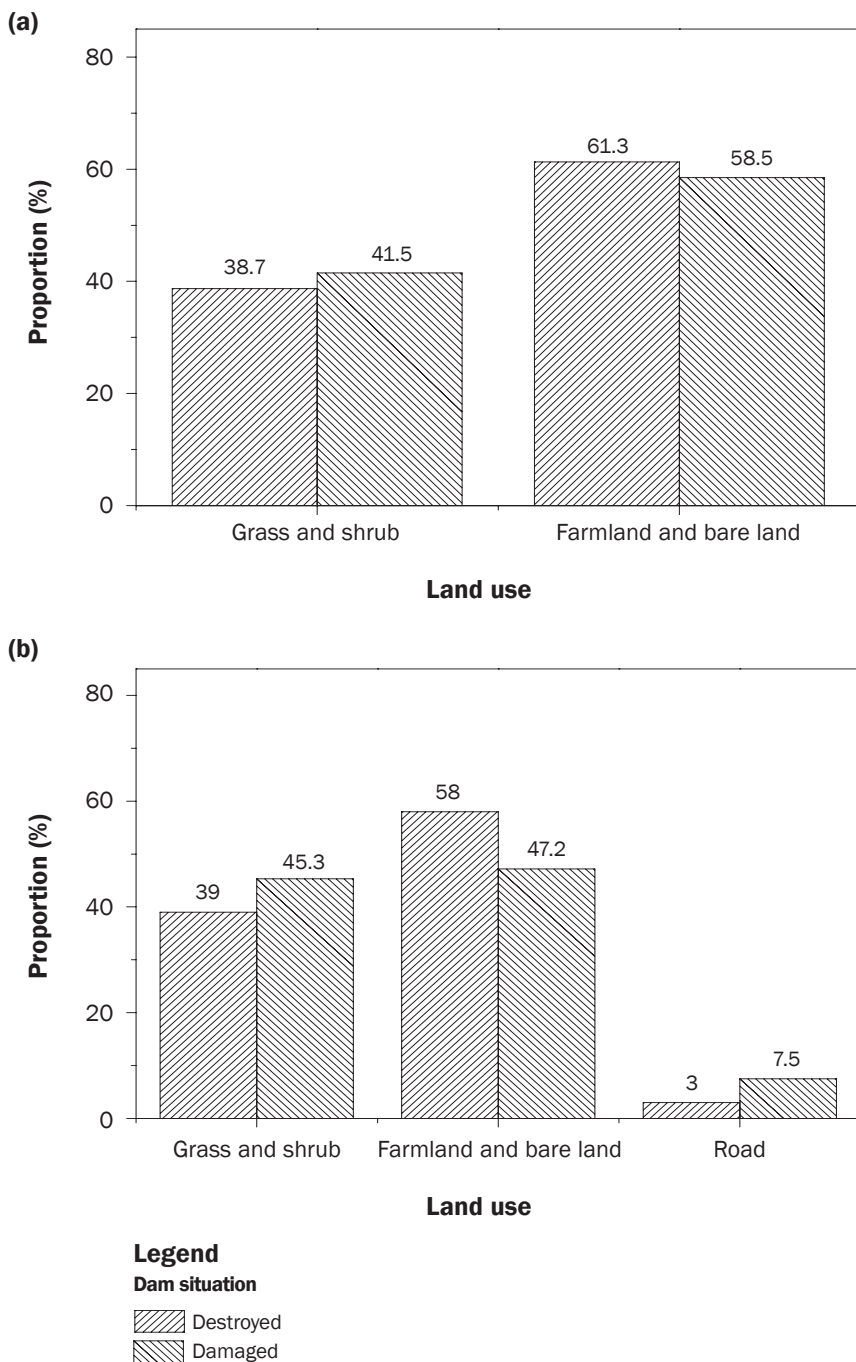
**Inappropriate Land Use on Check Dams.** Most of the check dams in the Chabagou watershed are earth-filled dams. Such dams involve a small investment; they are not very secure and can be easily destroyed by floods. Moreover, land use type can also influence dam security. Among the check dams that were destroyed, 38.7% were characterized by grass and shrubs on their upstream slopes,

while the other 61.3% were either characterized by farmland or bare land. Similarly, 39% of destroyed dams had grass and shrubs on their crests, while 58% had farmland or bare land. Among the damaged check dams, 41.5% had grass and shrubs on their upstream slopes, while the other 58.5% had farmland or bare land. Furthermore, 45.3% of damaged dams were characterized by grass and shrubs on their crests, while 47.2% were characterized by farmland or bare land (figure 7). Hence, the percentages of farmland and bare land were larger than that of grass and shrub for both destroyed and damaged dams. The anti-scour ability of farmland and bare land is generally relatively poor, thus resulting in rill erosion, shallow gully erosion, and poor stability of the check dams. These aspects mean that the dams in the study area would have been more easily destroyed

under extreme rainfall. Conversely, grass and shrub on the upstream slopes and dam crest may have effectively protected the dams from being washed away.

**Figure 7**  
Land use and security of check dams on the (a) upstream slope and (b) crest.

Many dams become structurally unstable and dangerous after several years of operation and improper use. Dangerous check dams are becoming one of the main problems to be solved with respect to current and future soil erosion control on the Chinese Loess Plateau, and there is an urgent need to remove and strengthen dangerous check dams. Increased investment and a greater emphasis on assessing, maintaining, strengthening, and repairing dangerous dams are required—for example, by increasing the height of a dam body for those filled with sediment, repairing damage of the dam surface, and strengthening thin dam bodies. Moreover, this study found that the land use type on dam body had a significant effect on the dam stability. Crops were planted in some dam bodies, which led to poor stability of the check dams and meant they could be more easily destroyed by extreme rainstorms. It was not advisable to plant crops on the dams; the growth of natural grass and shrub should be encouraged to protect the dam.
