# Damage of check dams by extreme rainstorms on the Chinese Loess Plateau: A case study in the Chabagou watershed

Y. Yang, S. Fu, B. Liu, B. Sun, C. Liu, Z. Wang, and S. Wu

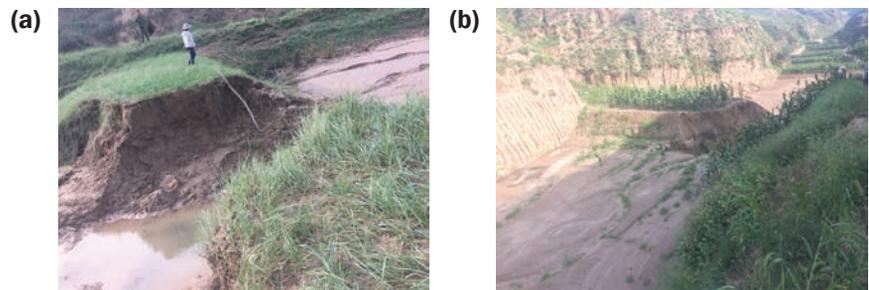
### Figure 3

The check dams were destroyed in the manner of openings or culverts, as shown in table 3. The openings in the dam bodies ranged from 0.6 m to 23.3 m wide (mean of 4.8 m) and from 0.4 m to 14.8 m in depth (mean of 3.4 m). The widths of the culverts were between 0.3 m and 7.2 m (mean of 1.7 m), while their depths ranged between 0.4 m and 5.5 m (mean of 2 m). The majority of the dams that were destroyed by openings

Destroyed check dams during the “7.26” rainstorm. A destroyed dam indicates that the flood waters created an opening or culvert in the dam body, which allowed water to move from the upstream to the downstream of the dam. (a) An opening on a dam body across a stream, and (b) an opening on a dam body across silt-up dam land.

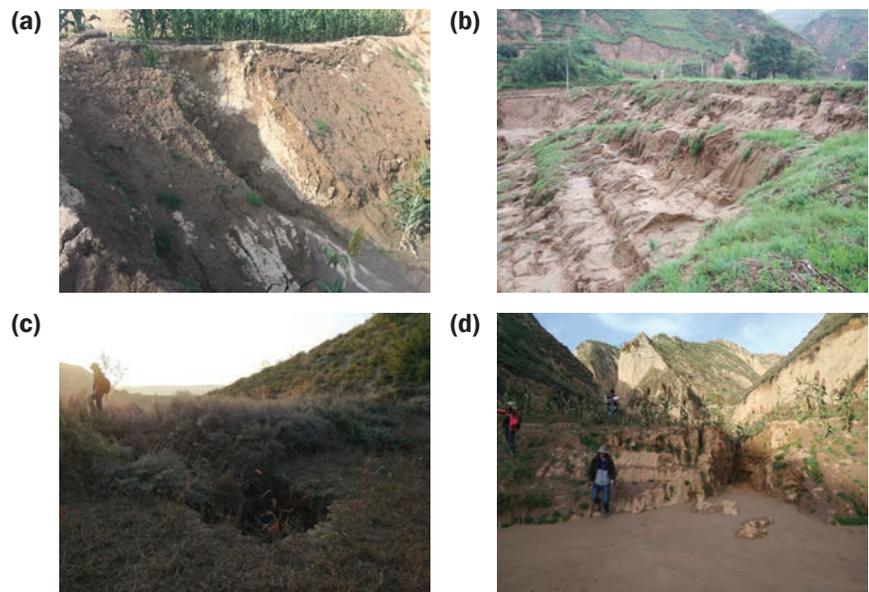
### Figure 4

Damaged check dams during the “7.26” rainstorm. A damaged dam indicates that the dam body was intact, but that rills developed on the upstream slope, downstream slope, or top of the dam. (a) Minor damage on the upstream slope of a check dam; (b) severe erosion on the downstream slope of a check dam; (c) cave-in on the downstream slope of a check dam; (d) minor damage on the downstream slope of a check dam.

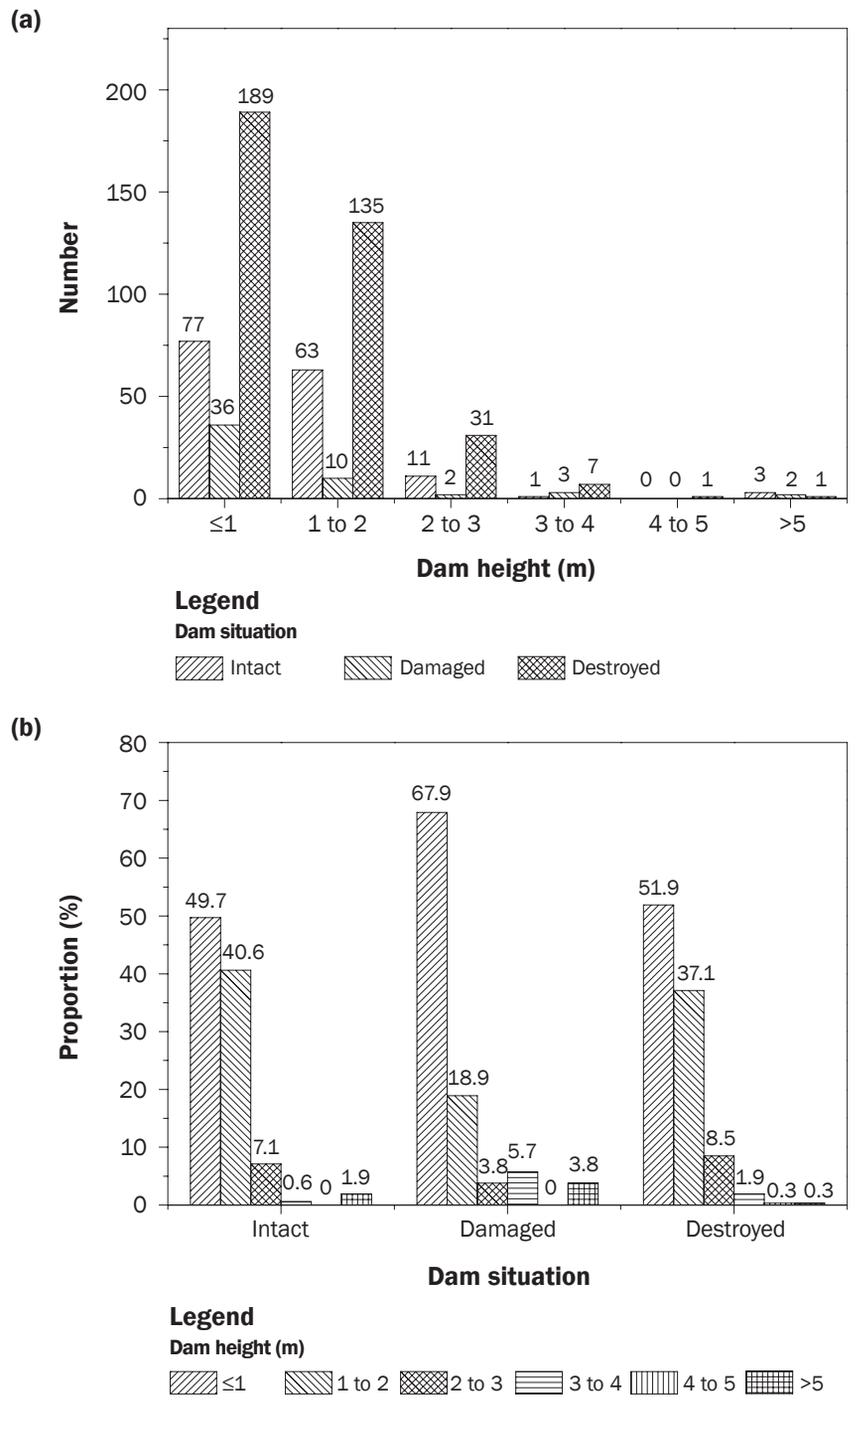
**Damage to the Check Dams.** As shown in figure 5, the numbers of intact, damaged, and destroyed dams were 155, 53, and 364, respectively, thus accounting for 27.1%, 9.3%, and 63.6% of the total. Check dams with heights of <1 m were the most likely to be damaged or destroyed, and accounted for 67.9% of damaged dams and 51.9% of destroyed dams. Moreover, 86.8% and 89.0% of damaged and destroyed dams, respectively, were <2 m in height. These results indicate that the majority of check dams were severely damaged by the “7.26” extreme rainstorm on July 25 and 26, 2017.

**Figure 5**  
 (a) Number of check dams and (b) proportion of check dams in intact, damaged, and destroyed situation as classified by dam height.

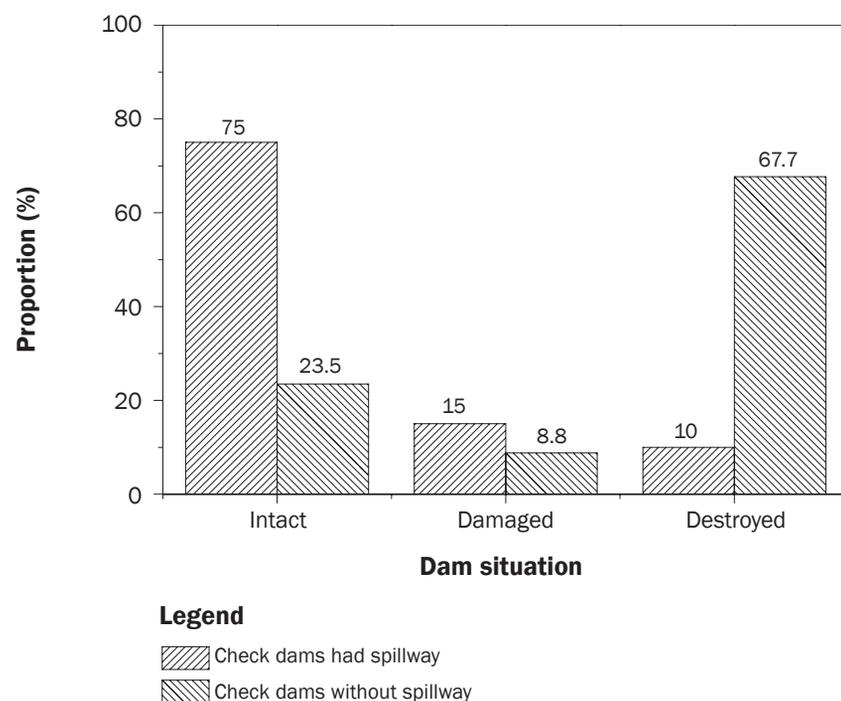
**Poor Drainage Capacity.** A spillway is a flood control accessory that is designed to drain flooded to downstream areas when the water level exceeds a dam's safety limit, thus protecting the dam from damage that could be caused by overflow. In this study, only 34 check dams had spillways (table 1), 75% of which remained intact, while only 15% were damaged and 10% were destroyed. However, for the check dams without spillways, 23.5% remained intact, 8.8% were damaged, and 67.7% were destroyed (figure 6). Hence, dams with spillways largely remained intact and suffered considerably less destruction during the rainstorm in comparison to those without spillways.

vious floods and served as spillways in the "7.26" rainstorm. In some cases, the bottom of the spillway had become higher than the dam crest due to inadequate maintenance, and the spillway lost its ability to function as a means of flood discharge. Thus, the lack of a spillway and inadequate maintenance meant that flood waters were not discharged in time, which may have also been responsible for the damage caused to dams during the extreme rainstorm.

**Figure 6**  
Spillway and security of check dams.

significant effect on the lifespan and efficiency of the surveyed check dams. It can therefore be concluded that there is a need to increase the dam construction standard and build spillways. The design of spillways should take into account the proper type, size, and location of the cross-section as a means of ensuring that dams are not overtopped and do not collapse as a result of extreme rainstorms and floods. The silted sediment on spillways should be frequently cleared, especially before the rainy season, in order to ensure that flood water can be discharged in time to protect the dam body. In addition, drainage systems should be designed and built to form artificial flow paths as a means of enhancing the drainage function and protecting the silt-up dam land.

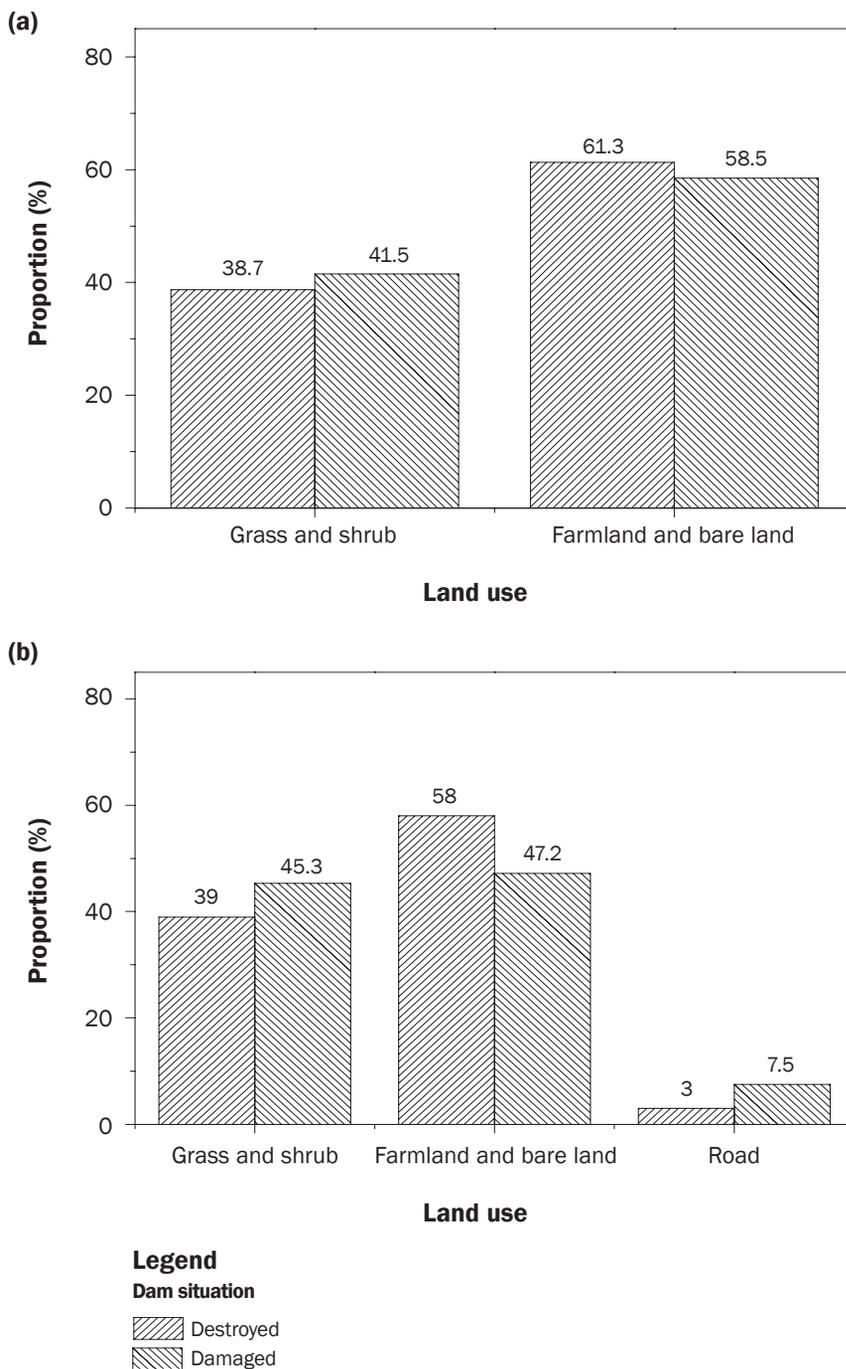
**Inappropriate Land Use on Check Dams.** Most of the check dams in the Chabagou watershed are earth-filled dams. Such dams involve a small investment; they are not very secure and can be easily destroyed by floods. Moreover, land use type can also influence dam security. Among the check dams that were destroyed, 38.7% were characterized by grass and shrubs on their upstream slopes,

while the other 61.3% were either characterized by farmland or bare land. Similarly, 39% of destroyed dams had grass and shrubs on their crests, while 58% had farmland or bare land. Among the damaged check dams, 41.5% had grass and shrubs on their upstream slopes, while the other 58.5% had farmland or bare land. Furthermore, 45.3% of damaged dams were characterized by grass and shrubs on their crests, while 47.2% were characterized by farmland or bare land (figure 7). Hence, the percentages of farmland and bare land were larger than that of grass and shrub for both destroyed and damaged dams. The anti-scour ability of farmland and bare land is generally relatively poor, thus resulting in rill erosion, shallow gully erosion, and poor stability of the check dams. These aspects mean that the dams in the study area would have been more easily destroyed

under extreme rainfall. Conversely, grass and shrub on the upstream slopes and dam crest may have effectively protected the dams from being washed away.

**Figure 7**  
Land use and security of check dams on the (a) upstream slope and (b) crest.

Many dams become structurally unstable and dangerous after several years of operation and improper use. Dangerous check dams are becoming one of the main problems to be solved with respect to current and future soil erosion control on the Chinese Loess Plateau, and there is an urgent need to remove and strengthen dangerous check dams. Increased investment and a greater emphasis on assessing, maintaining, strengthening, and repairing dangerous dams are required—for example, by increasing the height of a dam body for those filled with sediment, repairing damage of the dam surface, and strengthening thin dam bodies. Moreover, this study found that the land use type on dam body had a significant effect on the dam stability. Crops were planted in some dam bodies, which led to poor stability of the check dams and meant they could be more easily destroyed by extreme rainstorms. It was not advisable to plant crops on the dams; the growth of natural grass and shrub should be encouraged to protect the dam.
