Damage of check dams by extreme rainstorms on the Chinese Loess Plateau: A case study in the Chabagou watershed

Y. Yang, S. Fu, B. Liu, B. Sun, C. Liu, Z. Wang, and S. Wu

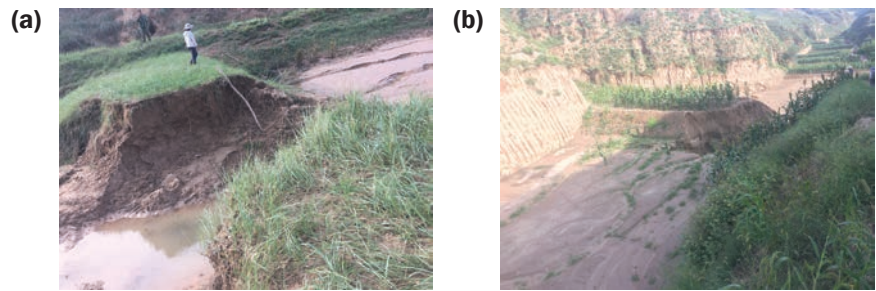
Figure 3

The check dams were destroyed in the manner of openings or culverts, as shown in table 3. The openings in the dam bodies ranged from 0.6 m to 23.3 m wide (mean of 4.8 m) and from 0.4 m to 14.8 m in depth (mean of 3.4 m). The widths of the culverts were between 0.3 m and 7.2 m (mean of 1.7 m), while their depths ranged between 0.4 m and 5.5 m (mean of 2 m). The majority of the dams that were destroyed by openings

were <4 m in height, while the majority dams that were destroyed by culverts were <3 m in height.

Destroyed check dams during the “7.26” rainstorm. A destroyed dam indicates that the flood waters created an opening or culvert in the dam body, which allowed water to move from the upstream to the downstream of the dam. (a) An opening on a dam body across a stream, and (b) an opening on a dam body across silt-up dam land.

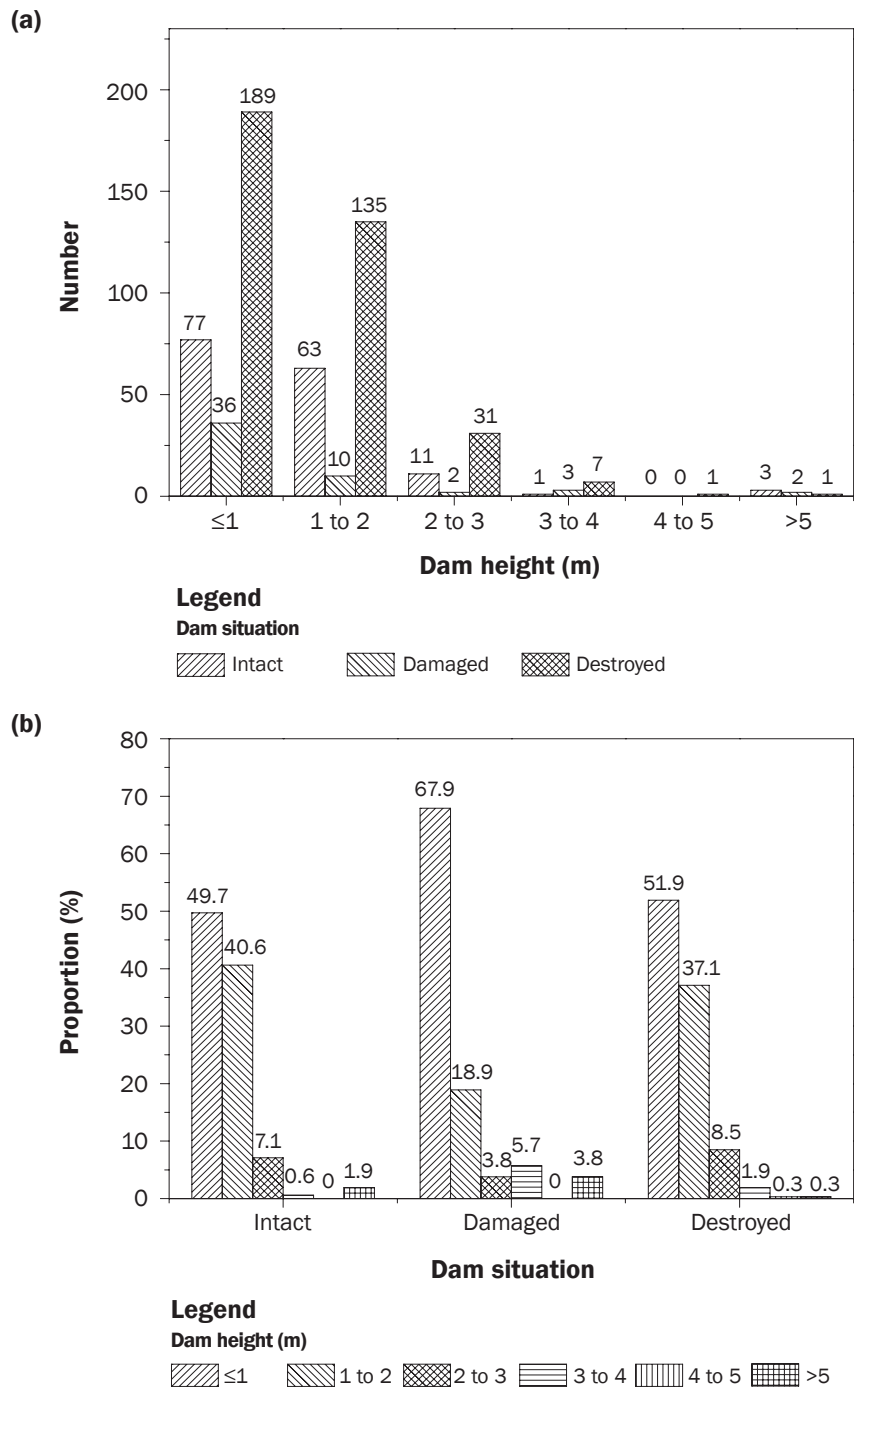
Damage to the Check Dams. As shown in figure 5, the numbers of intact, damaged, and destroyed dams were 155, 53, and 364, respectively, thus accounting for 27.1%, 9.3%, and 63.6% of the total. Check dams with heights of <1 m were the most likely to be damaged or destroyed, and accounted for 67.9% of damaged dams and 51.9% of destroyed dams. Moreover, 86.8% and 89.0% of damaged and destroyed dams, respectively, were <2 m in height. These results indicate that the majority of check dams were severely damaged by the “7.26” extreme rainstorm on July 25 and 26, 2017.

Figure 5
 (a) Number of check dams and (b) proportion of check dams in intact, damaged, and destroyed situation as classified by dam height.

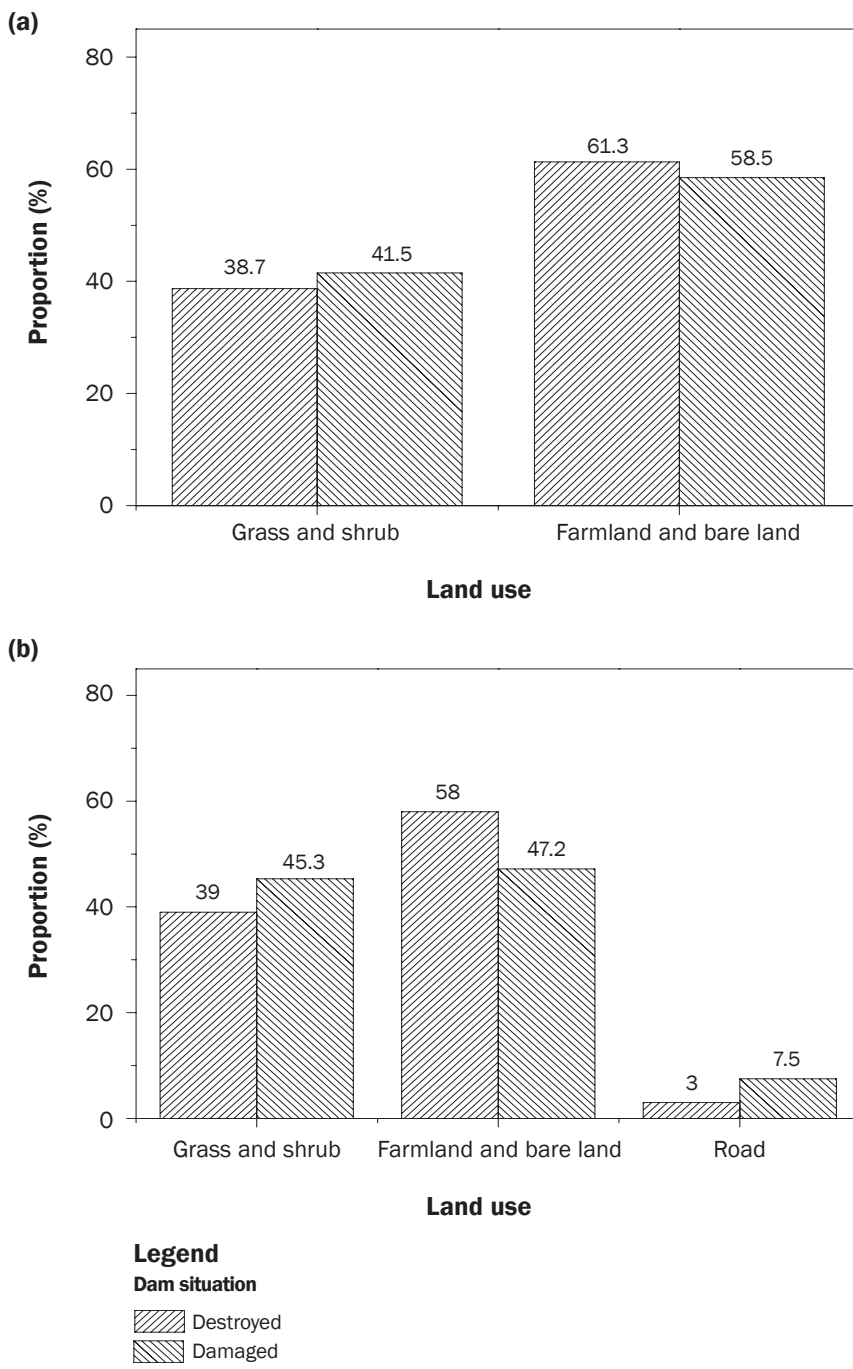
Inappropriate Land Use on Check Dams. Most of the check dams in the Chabagou watershed are earth-filled dams. Such dams involve a small investment; they are not very secure and can be easily destroyed by floods. Moreover, land use type can also influence dam security. Among the check dams that were destroyed, 38.7% were characterized by grass and shrubs on their upstream slopes,

while the other 61.3% were either characterized by farmland or bare land. Similarly, 39% of destroyed dams had grass and shrubs on their crests, while 58% had farmland or bare land. Among the damaged check dams, 41.5% had grass and shrubs on their upstream slopes, while the other 58.5% had farmland or bare land. Furthermore, 45.3% of damaged dams were characterized by grass and shrubs on their crests, while 47.2% were characterized by farmland or bare land (figure 7). Hence, the percentages of farmland and bare land were larger than that of grass and shrub for both destroyed and damaged dams. The anti-scour ability of farmland and bare land is generally relatively poor, thus resulting in rill erosion, shallow gully erosion, and poor stability of the check dams. These aspects mean that the dams in the study area would have been more easily destroyed

under extreme rainfall. Conversely, grass and shrub on the upstream slopes and dam crest may have effectively protected the dams from being washed away.

Figure 7
Land use and security of check dams on the (a) upstream slope and (b) crest.

Many dams become structurally unstable and dangerous after several years of operation and improper use. Dangerous check dams are becoming one of the main problems to be solved with respect to current and future soil erosion control on the Chinese Loess Plateau, and there is an urgent need to remove and strengthen dangerous check dams. Increased investment and a greater emphasis on assessing, maintaining, strengthening, and repairing dangerous dams are required—for example, by increasing the height of a dam body for those filled with sediment, repairing damage of the dam surface, and strengthening thin dam bodies. Moreover, this study found that the land use type on dam body had a significant effect on the dam stability. Crops were planted in some dam bodies, which led to poor stability of the check dams and meant they could be more easily destroyed by extreme rainstorms. It was not advisable to plant crops on the dams; the growth of natural grass and shrub should be encouraged to protect the dam.
