FEATURE

Slurry trenches and relief wells installed to strengthen Ohio and Mississippi river levee systems

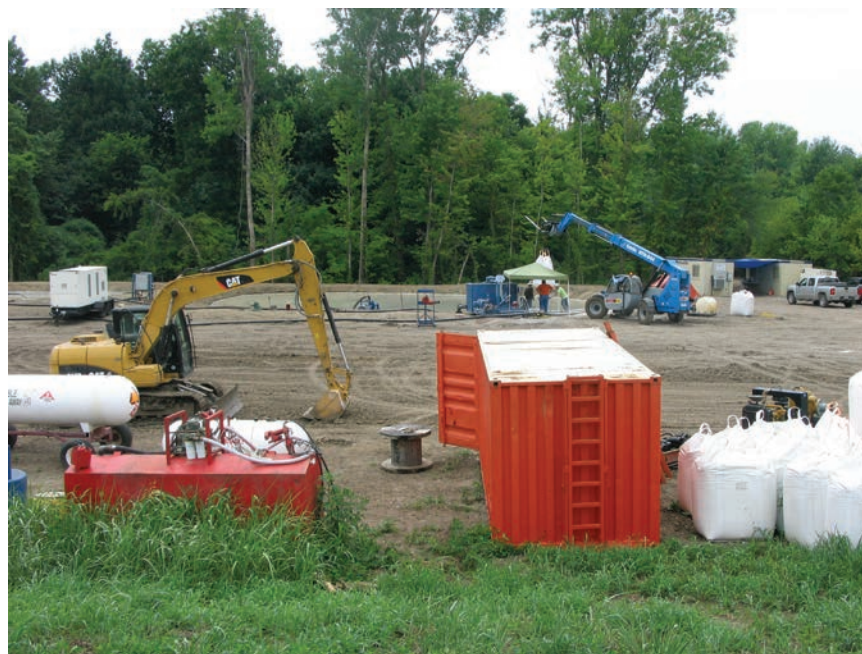
Figure 5

Two slurry ponds where the Bentonite bags were dumped and mixed with water to create slurry for the trench.

A 1,782 m (5,400 ft) slurry trench and two berms were added to the Ohio River levee system between Mound City and Cairo north of the Ohio River floodwall (figures 1, 5, and 6) east of Route 37 and south of the Cache River levee. These projects were designed to prevent seepage during future major flooding, and all work was completed by November of 2013. Another project flattened the slope on the Mississippi River levee and widened its crown. Improvements including work on pump stations, drainage systems, and small levees, some of which failed in April of 2011, were completed in the Cache River Valley area north of Cairo. These projects were funded by the county matching funds with the USACE and combinations of grants from the Delta Regional Authority and the state of Illinois (Koenig 2012). North of Cairo and south of the Cache River levee, the smaller towns such as Urbandale, Future City, and Klondike are now better protected from major flooding in the future.

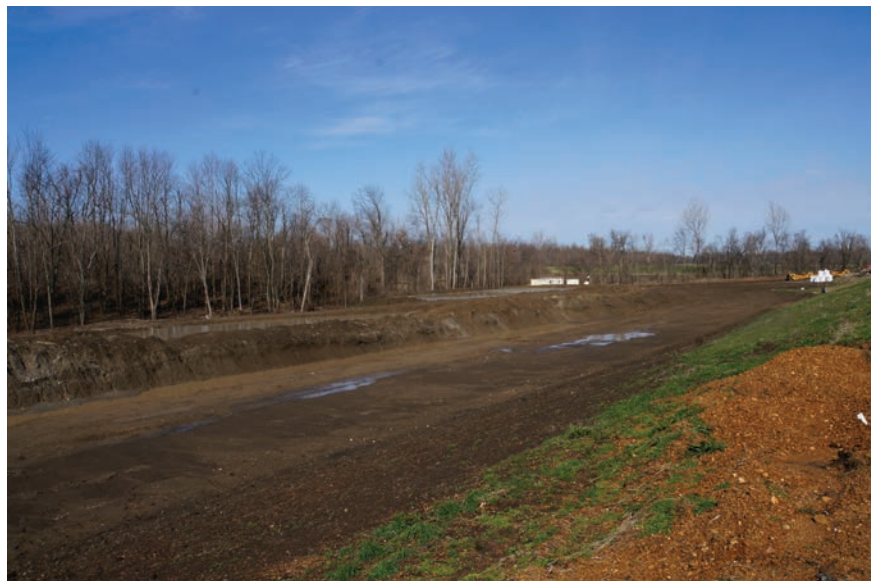
Figure 6

Slurry trench between the levee and Mississippi River.
