# Effectiveness of jatropha barriers as a soil and water conservation technology to rehabilitate gullies in northern Ethiopia

Albrecht Ehrensperger, Simon Bach, Hanspeter Liniger, Brigitte Portner, and Habtamu Ayele

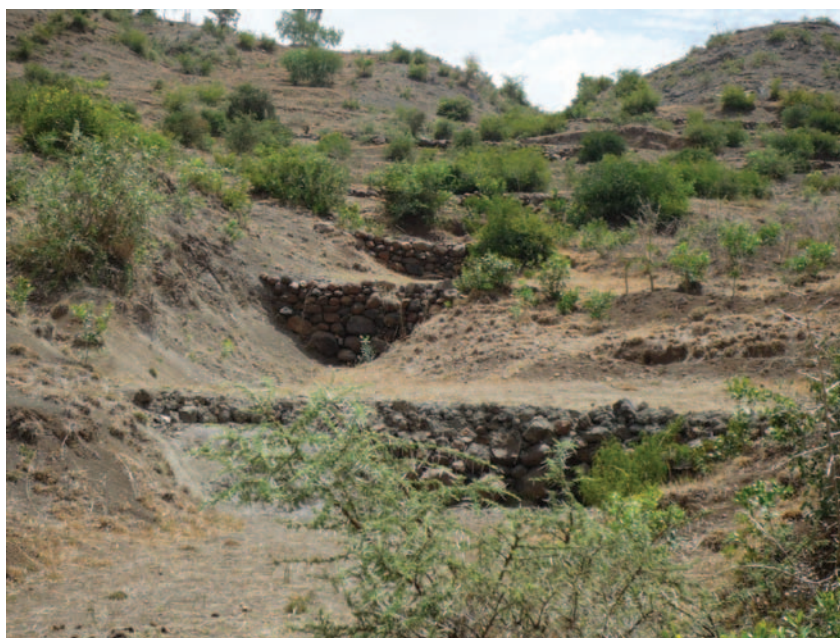
**Figure 3**

Sequence of small stone walls in a steep section of an inactive gully (Bach 2012).

Stone wall barriers are the most widely used structures to rehabilitate gullies in the two watersheds: there are 85 of them (63% of all barriers), totaling a length of 1,190 m (3,904 ft) in Tullu Iyensa and 479 m (1,572 ft) in Dodota (table 1; figures 2 and 3). Their main technical functions are to control concentrated runoff, reduce slope angle and length, increase water storage in the soil, and trap sediments in preparation

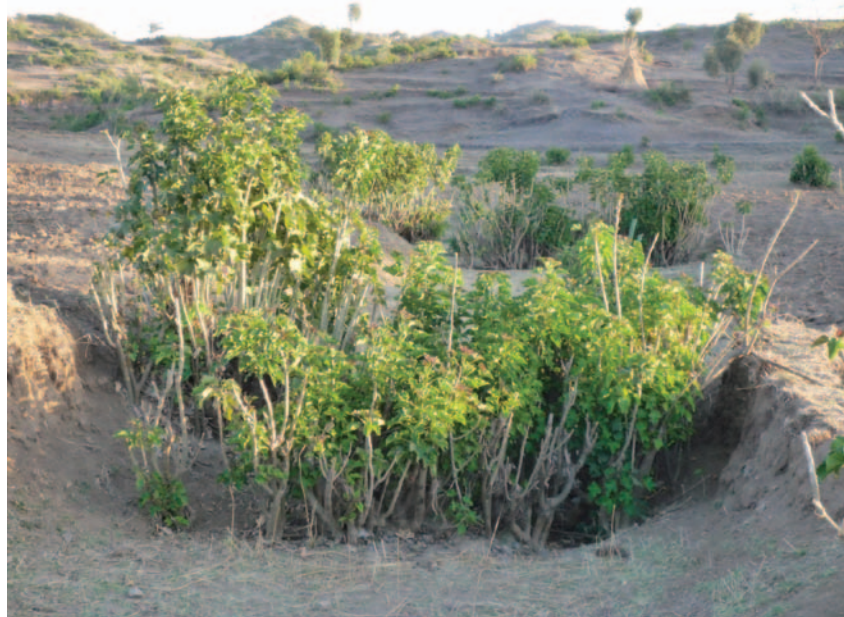
**Figure 4**

Sequence of small jatropha barriers in an inactive gully (Bach 2012).

Jatropha barriers for soil and water conservation are grown along hillsides and across gullies (figures 2 and 4). Their main technical functions are identical to those of stone walls (see above). This vegetative measure is not yet very popular in either of the two watersheds. Only 27 jatropha barriers were implemented (20% of all barriers), totaling a length of 103 m (338 ft) in Dodota and only 4 m (13 ft) in Tullu Iyensa (a single barrier in an inactive gully; see table 1). The usual propagation method is from cuttings, which are easily accessible since jatropha is widespread in the region.
