Impacts of 2008 flooding on agricultural lands in Illinois, Missouri, and Indiana

Kenneth R. Olson

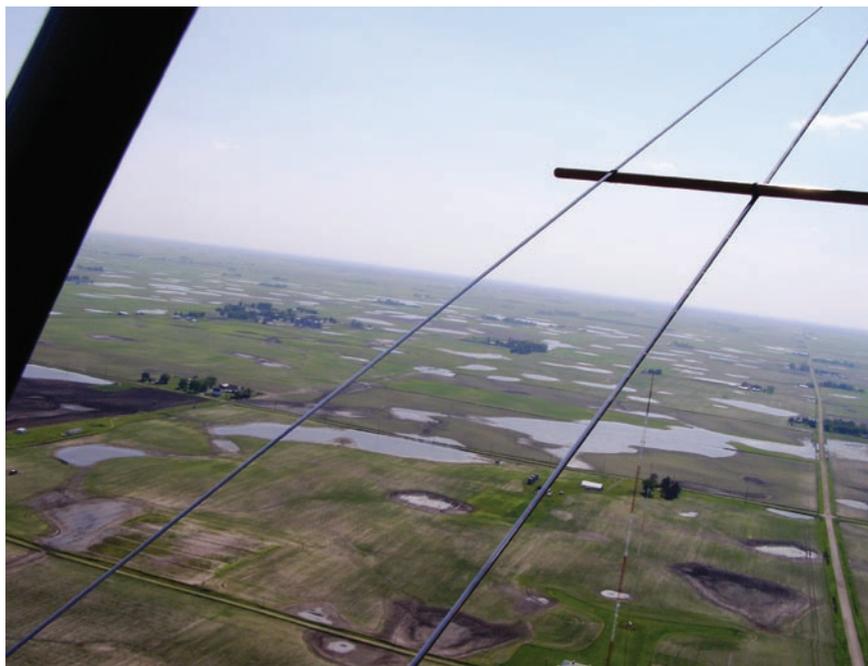
Figure 1

Photograph taken from a plane showing ponded depressions and pot holes on the uplands in central Iowa after heavy June 2008 rain. Photo credit: Eddie Miller, Benson Motor Inc., Ames, Iowa.

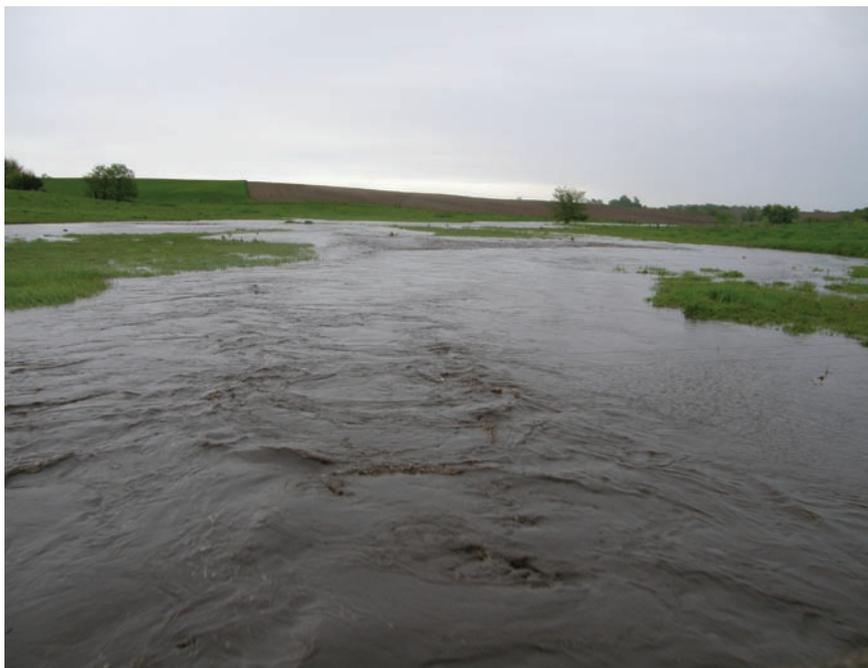
Figure 2

Waterway in central Iowa full of rapid runoff water moving and overflowing into the surrounding pasture on May 30, 2008. Photo credit: Lois Wright-Morton, Iowa State University, Ames, Iowa.

However, many waterways were filled above capacity and were eroded by fast-moving water or had significant sediment deposition. Culverts and other drainage structures were often plugged by soybean and corn residue, primarily from no-till systems residue. No-till systems did reduce raindrop impact and erosion, but once overland flow started on sloping lands, the residue was transported into the streams, blocked drainageways and structures, and resulted in local flooding of fields and even highways. Water storage structures, such as retention ponds, filled quickly with water and in some cases were covered by floodwaters. Risers and tile outlets were often insufficient to drain crop areas within 24 or 48 hours, resulting in significant numbers of corn and soybean plants lost. Some areas were eventually replanted to corn or soybeans.

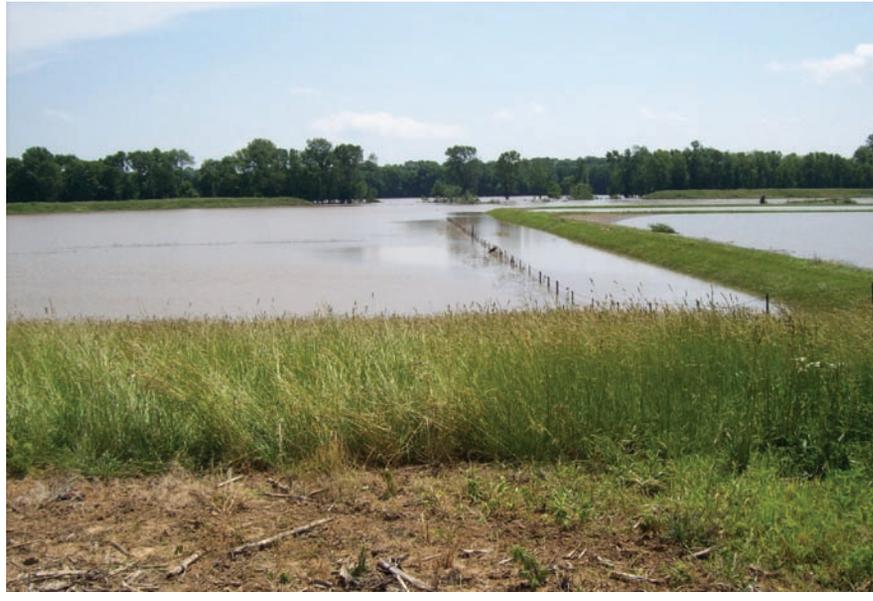
Figure 3

Full temporary storage ponds surrounded by flooding from Embarras River near Sainte Marie, Illinois, in June of 2008. Photo credit: Ken Flexter, Jasper County NRCS Field Office, Newton, Illinois.

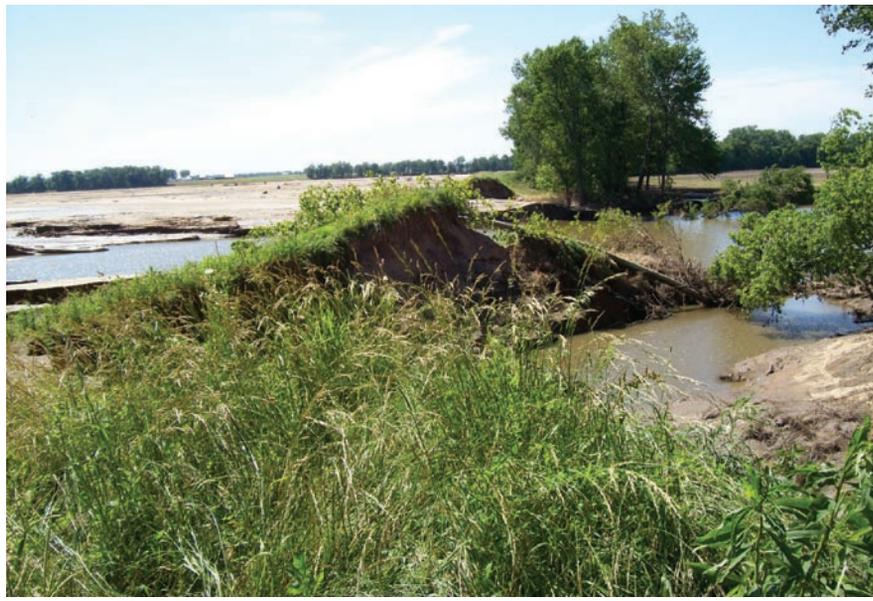
Figure 4

The areas that were not protected by levees and flooded only received a thin layer of silt and clay. The 2008 crop was lost, but soils did not suffer permanent damage. This was not the case where levees failed. Water removed hundreds of meters (hundreds of feet) of the levee embankments (figure 4) and eroded thousands of cubic meters (thousands of cubic feet) of soils

The Embarras River cutting through a levee near Sainte Marie, Illinois, in June of 2008. Photo credit: Ken Olson, ACES, University of Illinois, Urbana, Illinois.

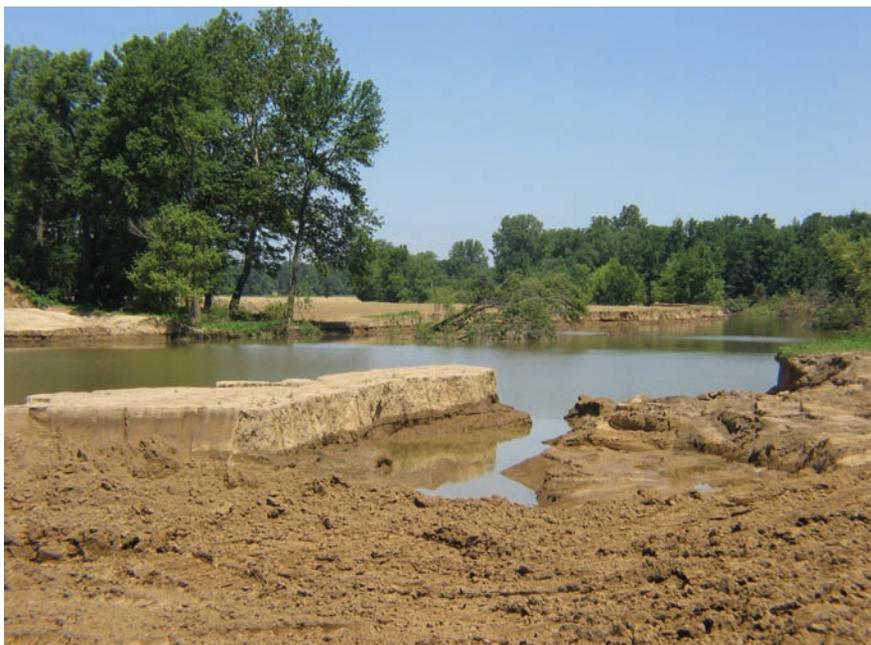
Figure 5

and underlying outwash parent material to depths of 3 to 6 m (10 to 20 ft) below the base of the earthen levee when the levees broke (figure 5). The force of the rushing water uprooted trees growing between the river and the levee prior to the break and deposited them on the previously protected floodplain (figure 6). The 2008 crop on the floodplain soils behind the broken levees was a total loss.

This situation happened at two levee breaks southeast of Sainte Marie, Illinois. About 90 m (295 ft) of levee was lost at each break. Blowout holes or craters were created that were 0.4 to 1.2 ha (1 to 3 ac) in size and held water. One to three meters (3 to 10 ft) deep gullies extended a few hundred meters (few hundred feet) into the previously protected floodplain, and hundreds of 20 m (65 ft) high trees were transported hundreds of meters (hundreds of feet) onto the previously protected floodplain. Deltaic sand deposits up to 0.5 m (1.6 ft) thick covered 30 ha (74 ac) or more on the floodplain at each site, with an additional 80 ha (198 ac) covered with a few centimeters (few inches) of sand. The remaining hundreds of hectares (hundreds of acres) of previously protected floodplain soils received a thin coating of silt and clay and remained under floodwaters long enough to drown out this year's crop if it was planted and not already removed by the wall of advancing water. The road and drainage ditches on the previously protected floodplain were also filled with sand more than 2 km (1.2 mi) from the levee break. By June 23, 2008, the water had drained from the floodplains and back into the Embarras River, sufficiently for the local farmers to hire contractors with bulldozers, pans, graders, back hoes, and buckets to begin the task of moving the trees from near the blowout holes and floodplain and to begin filling in the craters and gullies (figure 7). In addition, they began creating temporary levee embankments either around the blowout hole or across it to prevent any future flooding. The material for the temporary levee was obtained from the thick sand deposit beyond the blowout holes, transported to the edge of the blowout hole or crater and then compacted by a bulldozer. Other equipment was used to scrape and pile the

In the background is the Embarras River, Illinois, adjacent to the missing 90 meter section of the levee and the crater lake that was created by rushing waters. Photo credit: Ken Olson, ACES, University of Illinois, Urbana, Illinois.

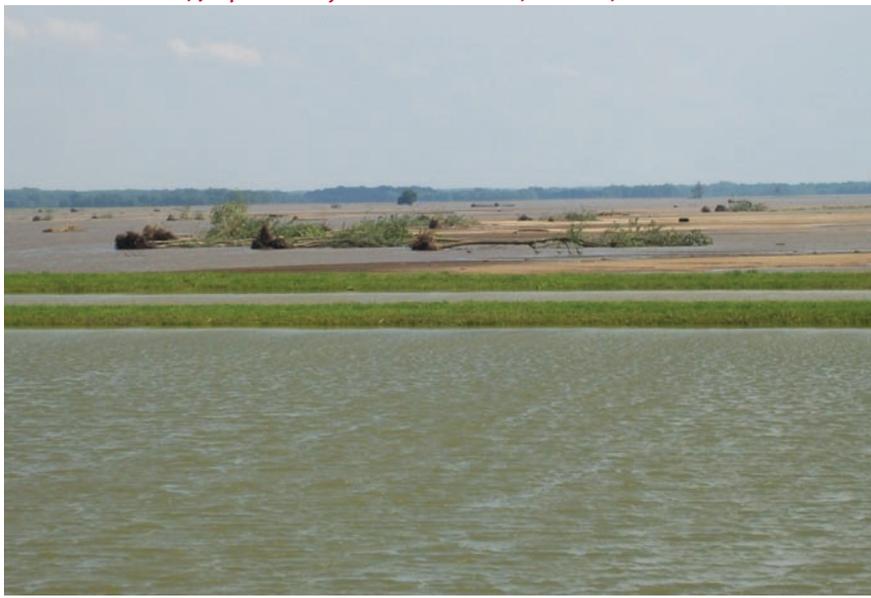
Figure 6

Agricultural fields covered by deltaic sand deposits, water, and trees moved and deposited by rushing water through a levee break on Embarras River, Illinois. Photo credit: Ken Flexter, Jasper County NRCS Field Office, Newton, Illinois.

sand come from?” He seemed to know that most of the surrounding Illinois soils were low in sand content. In fact, most of the upland soils formed in loess have less than 3% sand, and even the bottomland soils in the area have less than 15% sand. Apparently, the sand came from sand bars that may have developed in the river as the fine silts and clays were carried

beyond where the sand dropped onto the river bed. Also, the area is just south of the Wisconsin terminal moraine that was also topped thousands of years ago by rising water moving rapidly and depositing sandy outwash in the existing Embarras River valley. This underlying outwash is higher in sand and may have been used to create the levee embankment in the 1920s and 1930s. It is the parent material under the current alluvial soils at depths from 1 to 8 m (4 to 26 ft). The levee itself contained a higher sand content than the soils in the area, and significant sections of the levee were removed in addition to soil from the deep blowout hole. When the current Embarras River cut through the levee and dissipated sufficient energy to slow the water flow down, the sand dropped out and the remainder of the finer soil materials were carried further out into the valley floodplain.

sand either for use in the temporary dam or to fill in parts of the craters and gullies. Tillage equipment, such as chisel plows and moldboard plows, were used on the areas with thin sand deposits (<15 cm [<6 in]) in an attempt to mix the sand into the underlying silty and clayey topsoil.

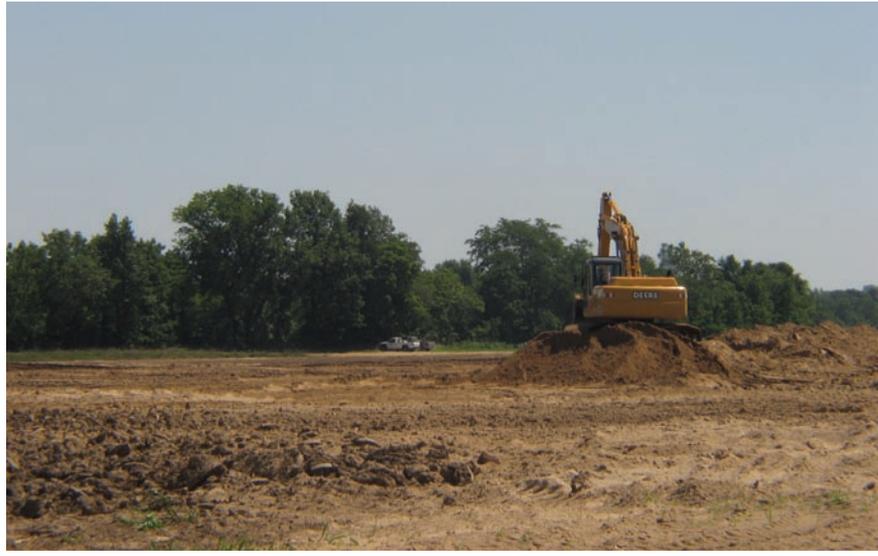
Figure 7

Sand being piled with a backhoe bucket for transport off the agricultural lands previously protected by a levee. Photo credit: Ken Olson, ACES, University of Illinois, Urbana, Illinois.

Agricultural lands were permanently lost when adjacent to levee breaks. In some situations, the land owners were patching the private levees, filling in the craters and gullies, removing the thick sand deposits, and tilling the thin sediment deposits into the topsoil to prepare for the next year's planting season.
