# Application and validation of a GIS-based stream bank stability tool for the Great Lakes region

Amanda G. Stone, Mark S. Riedel, Travis Dahl, and James Selegean

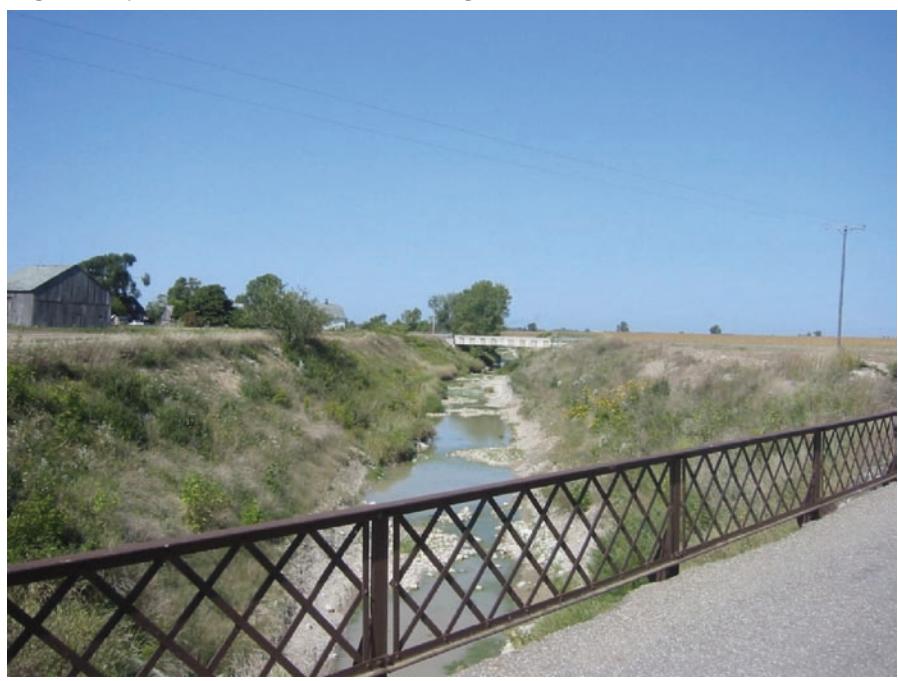
## Figure 1

Example of channel exhibiting bank failure within the Sebewaing River watershed, Saginaw Bay, Lake Huron, East Central Michigan.

of bank soils, making them vulnerable to erosion and bank failure and resulting in increased fluvial sediment loads to Sebewaing Harbor. Figure 1 is an example of a typical channel within the Sebewaing watershed that is experiencing bank failure and bed scour, the causes of which have not been previously investigated.

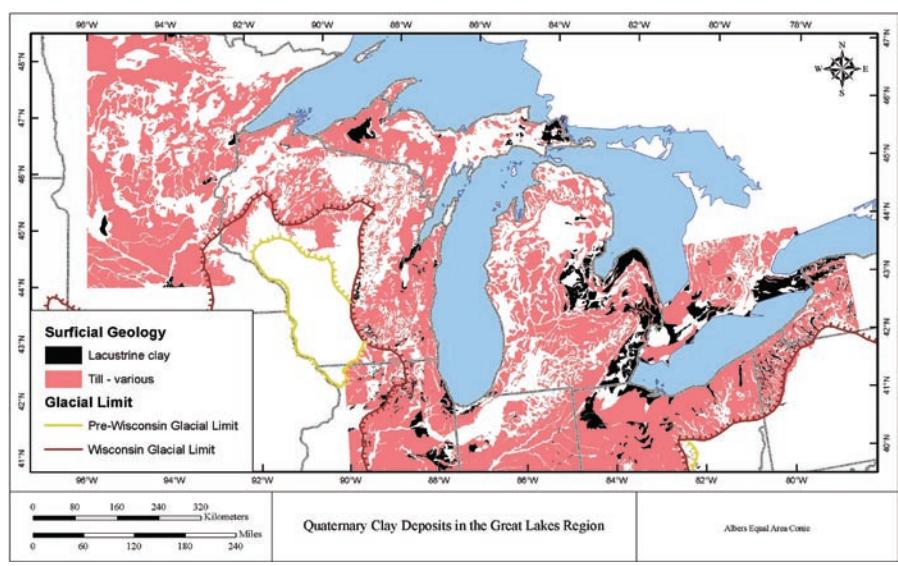
## Figure 2

Quaternary lacustrine clay and clay till deposits in the Great Lakes region (with data from Soller and Packard 1998).

**Geology of Study Area.** Quaternary glacial deposits dominate the surficial geology of the area, which includes widespread deposits of cohesive clay-dominated till and lacustrine clay plains throughout the Great Lakes region (figure 2). Natural clay channel streams in this setting can be quite resilient because clay dramatically increases the cohesive strength of soils, stream banks, and channel resistance to scour (Riedel et al. 2006; Schumm 1960).

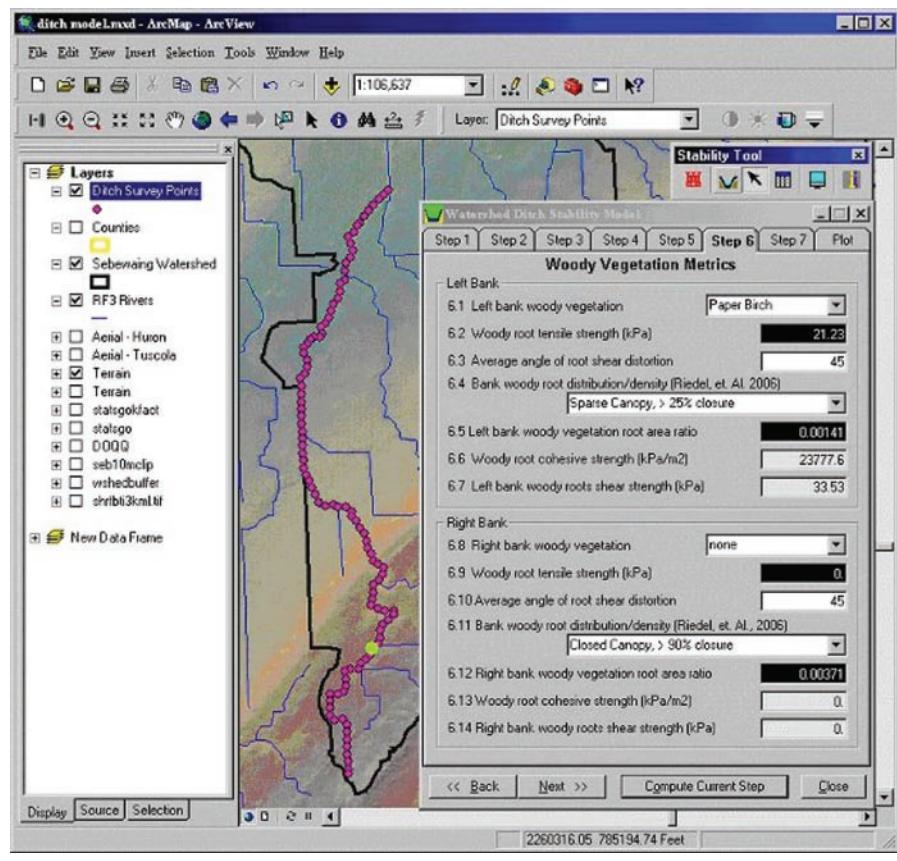
**Figure 3**

Example illustrating step 4 from the application scenarios (woody vegetation metrics) in the CST interface within ArcGIS.

The CST interface guides the user through a seven-step process using a combination of user input and data from built-in databases to complete stability calculations. The first two steps query field-surveyed geometry data from GIS files and calculate channel hydraulic variables. Geotechnical properties of the banks are calculated from soil bulk density and cohesive strength (either entered directly or calculated from soil clay content with typical values for the region provided). Critical shear stress values for soils of the Great Lakes are available in pull-down menus or can be entered manually. Vegetation type and cover for each bank can be selected from a built-in database of root tensile strength data for woody and herbaceous vegetation (see figure 3). With each step in the CST, the user

can manually override data to simulate alternative channel condition scenarios and estimate resultant impacts on stability. The results tab displays the results of F.S. for bank scour, bank stability, and bed scour. Results are displayed in color-coded format to indicate stable (green), unstable (red), or the threshold range of (in)stability (yellow). Results can be saved to a .dbf file that can be viewed (as tabular data or channel cross section) within the CST and exported for use with other software. Channel cross sections can also be plotted within the CST.

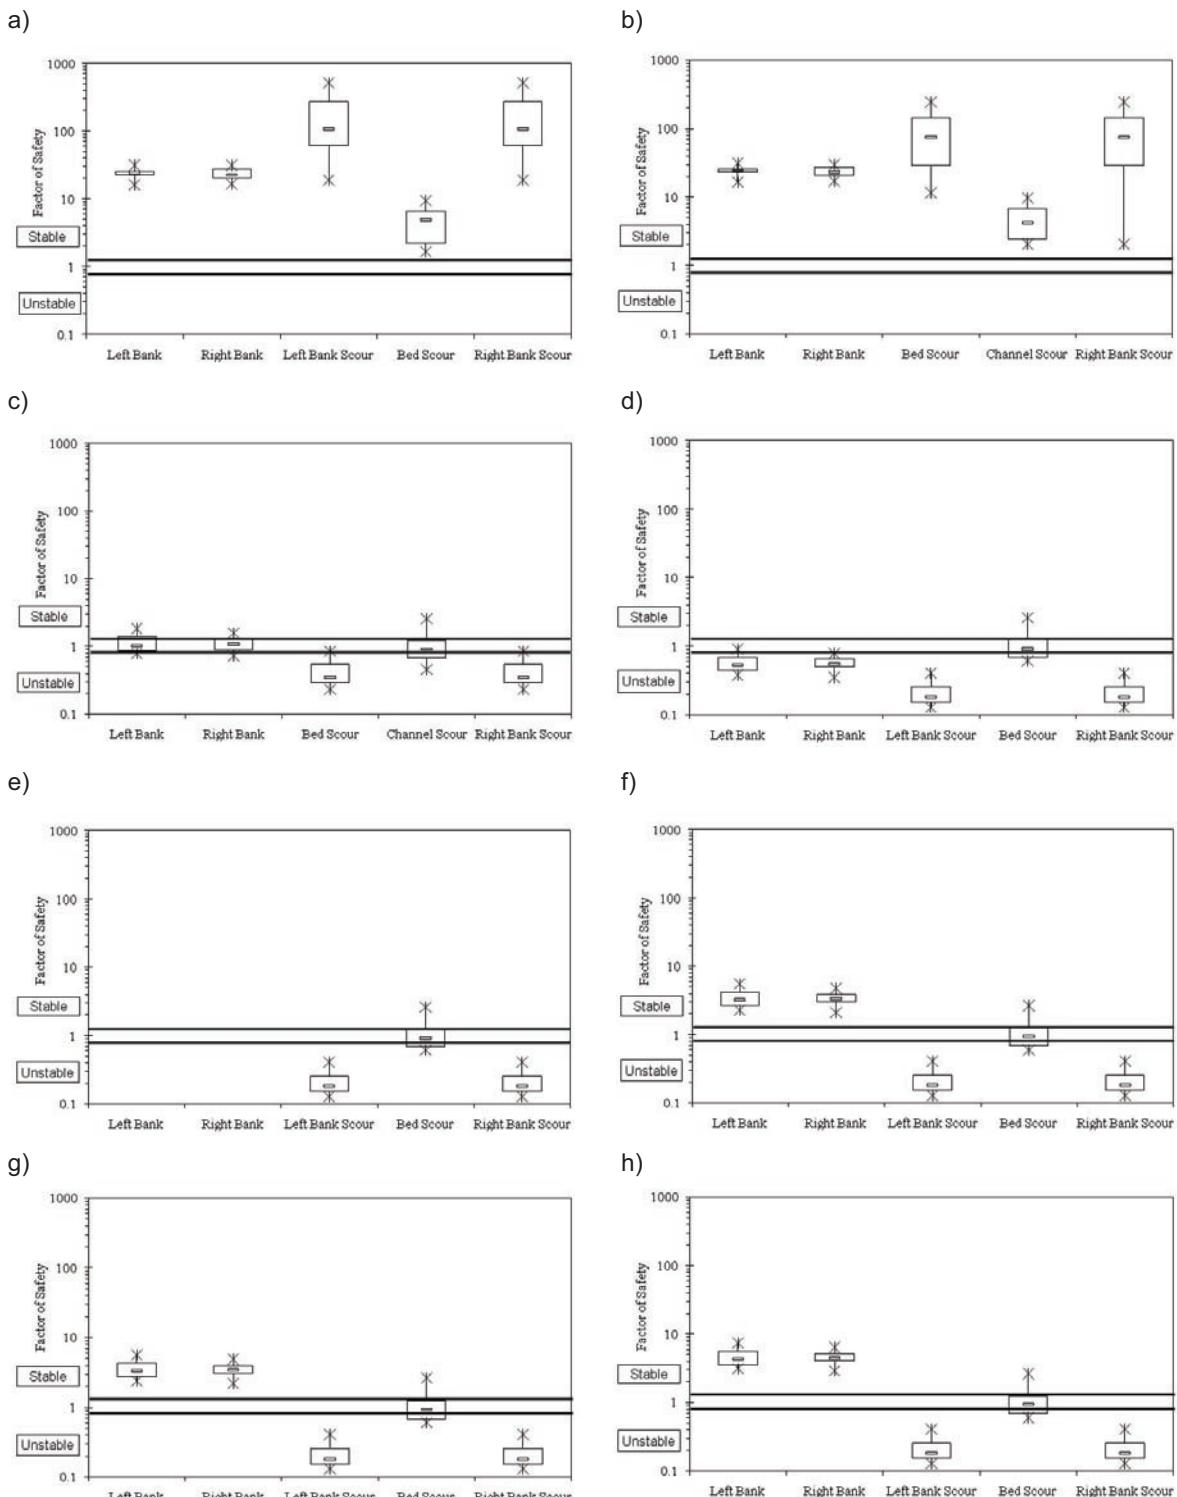
**Figure 4**

Stability results from applications of the CST: (a) Pre-dredged channel under bankfull flow, (b) Bankfull channel, post-dredging, (c) Half-full channels with ryegrass covered banks, (d) Full-channel flow with ryegrass covered banks, (e) Full-channel flow with bare banks, (f) Full-channel flow with shrub cover, (g) Full-channel flow with conifer tree cover, (h) Full-channel flow with deciduous tree cover.

The CST was applied to 10 cross-section locations for 2 validation and 4 application scenarios. Box and whisker plots illustrate the results of the tests on the 10 cross sections for each condition tested; the minimum, first quartile, median, third quartile, and maximum of the data served as the box and whiskers (figure 4). The range for the threshold of (in)stability (0.8 to 1.2) is depicted in this figure by lines labeling the “stable” and “unstable” threshold regions.

The pre-dredging and post-dredging bankfull conditions (validation scenario 1, figures 4a and 4b) were stable against bank

failure, bank scour, and bed scour for all cross sections tested because of the limited nature of dredging. However, dredging impacts on channel stability with respect to scour would be significant if banks are allowed to remain bare.

The higher flow conditions (validation scenario 2), including both half-full and full channels, produced anticipated results with significantly greater bank instability and scour potential as compared to the bankfull scenarios (see figures 4c and 4d). This was observed in areas within the drainage basin that experienced frequent flooding during the snowmelt season.

In the scenario with channels flowing half full (figure 4c), the stability values for bank failure were near the insipient point of failure. Results for bed scour were also near 1, but bank scour fell below the stable region with F.S. <0.8. Full-channel conditions pushed the F.S. for bank failure just into the unstable region (<0.8) and greatly reduced F.S. for bank scour (figure 4d). These results are consistent with field observations that showed evidence of general channel instability with bank failures and bank and bed erosion evident as slumping banks and channel scour that exposed bridge pier footings along the study reaches. The bare banks scenario showed significant instability for the banks, with the F.S. well below 0.1 for full-channel flow (figure 4e).

Bed scour (incision) showed a similar trend in the half-full channel (figure 4c) scenario due to the topography of the Sebewaing watershed. The lower reaches of the drains had higher F.S. values for bed scour under bankfull flow conditions because of the more gentle terrain and thus lower channel slopes. Higher in the watershed, the terrain becomes more

varied and channels have higher slopes, thus increasing the erosive power of the streams; F.S. for bed scour was significantly lower here—approximately one half the values observed in the lower portions of the watershed. With higher flow conditions typical during snowmelt runoff, all reaches were near or below the stability range for bed scour.

During full-channel flows, the CST indicated banks were unstable against bank failure even with ryegrass cover on the banks (figure 4d). These results reflect instability that was observed in the field. Figure 1 shows a typical cross section within the Sebewaing watershed that experiences high-flow periods during the spring snowmelt. Bank failure, bank scour, and bed scour were common along these reaches. No observations of bank stability, bank scour, and bed scour for shrubs and tree cover were available since most channels within the Sebewaing watershed were only grass covered.

The application of the CST with shrub and tree cover (figures 4f, 4g, and 4h) demonstrates the potential impact proper vegetation management within the riparian area near the banks can have on bank stability. With the addition of either local shrubs or trees, bank stability during and after the snowmelt season increased. The use of a 50% shrub–50% ryegrass cover was predicted to increase bank stability six fold, on average, as compared to ryegrass-only covered banks. Results of the shrub cover application are shown in figure 4f. Coniferous and deciduous forest covers (figures 4g and 4h, respectively) resulted in very similar values to the shrub cover scenario, again showing significant increases in stability as compared to a ryegrass cover.
