The impacts of 2011 induced levee breaches on agricultural lands of Mississippi River Valley

Kenneth R. Olson and Lois Wright Morton

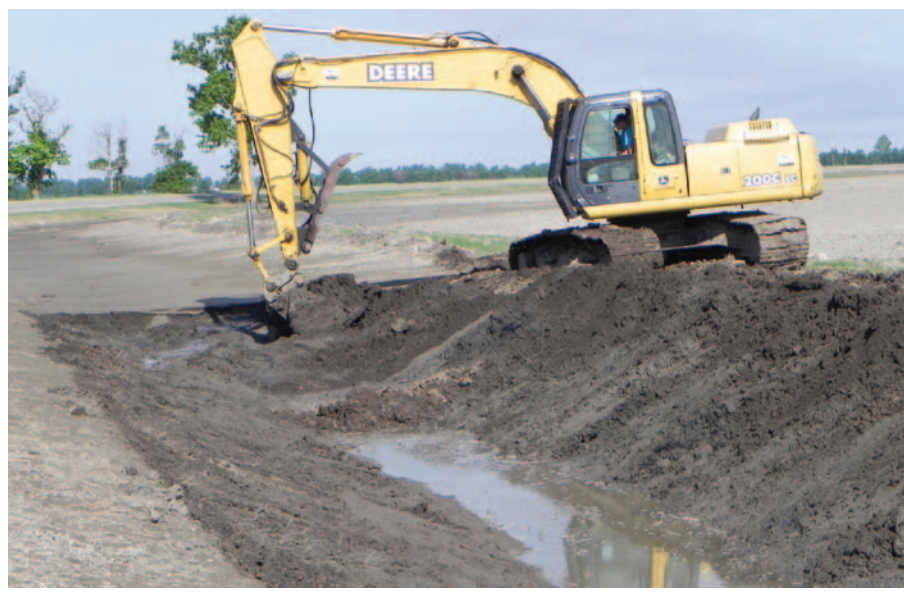
Excavator cleaning out sediment in road ditches. Photo courtesy of Brett Miller, Soil Conservation Technician, USDA Natural Resources Conservation Service.

The road and drainage ditches along Highway 77 in Mississippi County approximately 4 to 6 km (2.5 to 3.7 mi) south of Wyatt, Missouri, were filled with 0.9 to 1.8 m (3 to 6 ft) of sediment and sand. Figure 3 shows an excavator removing about 1.2 m (4 ft) of sediment from the road ditch. Irrigation systems were occasionally overturned by the force of water and wind and then buried by deltaic sand deposits (figure 4).

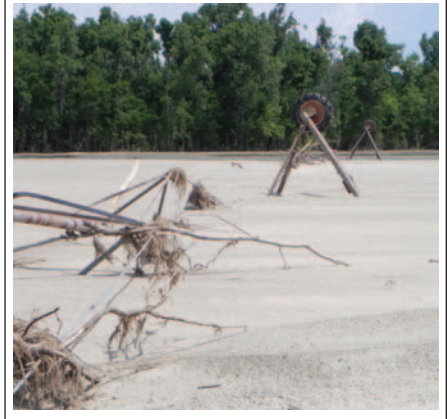
Figure 4
An irrigation system was overturned by the force of floodwater and wind and then buried by thick sand deposit. Photo courtesy of Brett Miller, Soil Conservation Technician, USDA Natural Resources Conservation Service.

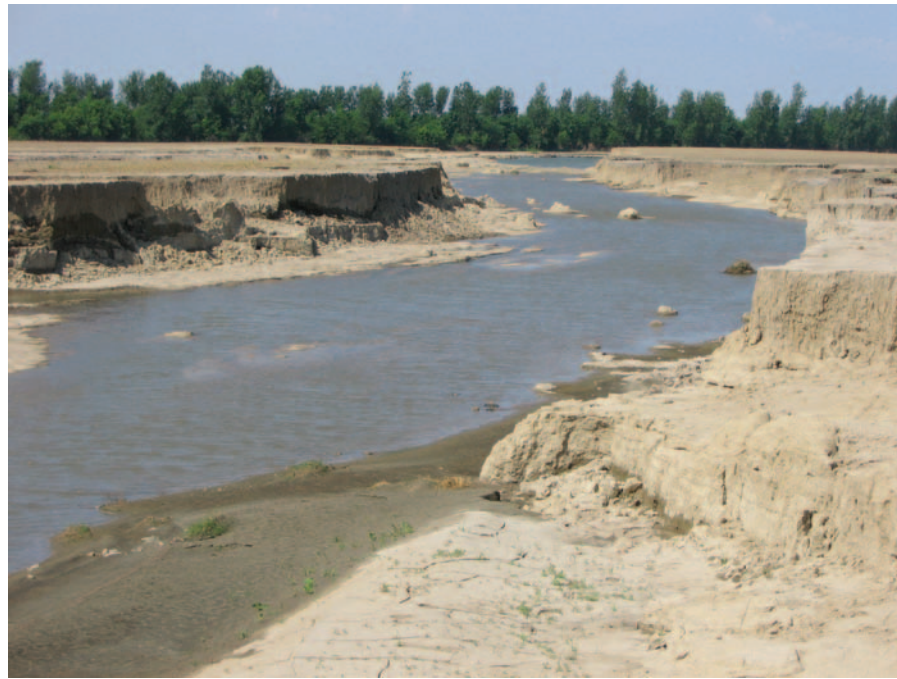
Figure 6

Gullies and channels that were created from May 4 to 16, 2011. The main channel and attached gullies were 3.7 m deep and removed more than 4 ha of cropland with an additional 4 ha of dissected field which could not be cultivated.

next to the levee breaches. Some of the gullies are 3.7 m (12 ft) deep, 45.8 m (150 ft) wide, and 1 km (0.6 mi) long (figure 6). A number of fields have these gullies, and

These gully lands will be extremely difficult to reclaim, and it is not clear how the land can be fully restored. The total amount of soil loss in metric tons has not been calculated, and the source of replacement soil will be difficult and costly to locate. Another option would be to regrade the vertical walls and reshape the fields with gullies into smooth rolling lands by filling in deepest craters with soil from the side slopes and crater walls. The new soils would be less productive than the previous alluvial soils (Olson and Lang 2000) due to the lower soil organic carbon content, greater slope, and lack of topsoil and subsoil material in the root zone. There is a health concern related to any pollutants that might be in floodwaters, such as untreated sewage from plants that were flooded or other chemicals picked up by floodwaters. When the organic and clay particles coating the plants and soils are dried, it is likely that sunlight will kill pathogens that might be present. Tillage could be used to bury or mix this potentially toxic coating into the topsoil layer, which will treat or dilute any toxic chemicals present. It is not known whether the soil organic carbon content of the alluvial soils would be increased as a result of sediment and exposure to carbon rich floodwater. It is anticipated that microbes will decompose the carbon deposited with the sediment or in the thin surface coating and release the carbon to the atmosphere as either carbon dioxide or methane gases, depending on whether there are aerobic or anaerobic conditions at the time the microbes are active.
