# The impacts of 2011 induced levee breaches on agricultural lands of Mississippi River Valley

Kenneth R. Olson and Lois Wright Morton

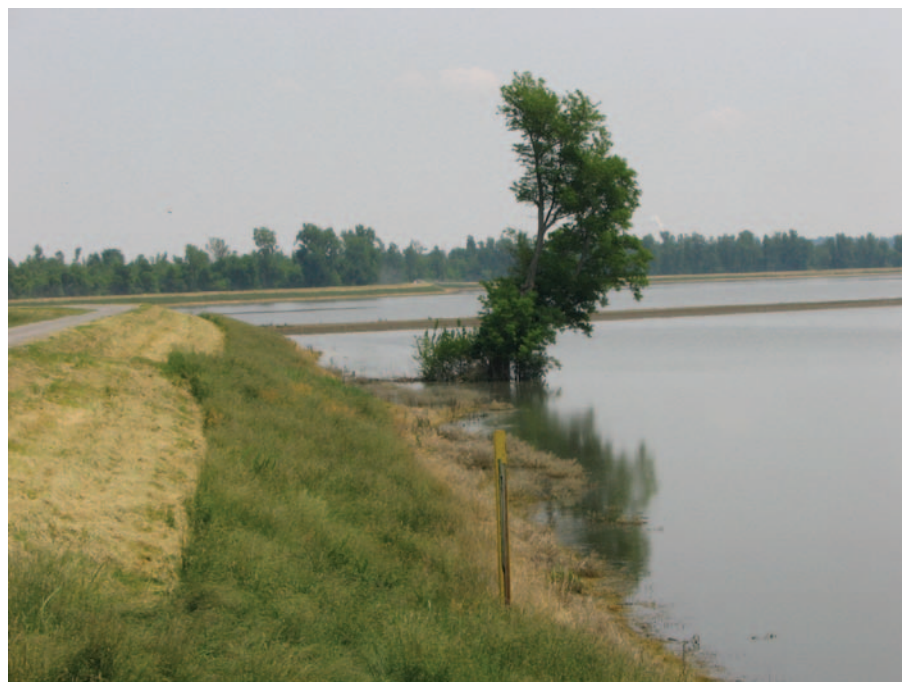
## Figure 2

The New Madrid Floodway and Basin still has 2 to 3 m of floodwater on May 20, 2011.

(figure 1) and border levees (figure 2) were built under the authority of Flood Control Act of 1928 (70th US Congress, Session 1 Chapter 596, enacted May 15, 1928) (FCA 1928). The Floodway is approximately 53.1 km (33 mi) long and is between 6.4 km (4 mi) and 16.1 km (10 mi) wide. The Floodway is enclosed by frontline and setback levees, except for a 457 m (1,500 ft) gap at the lower end which serves as a drainage outlet and allows flood backwaters to enter the Mississippi River. The

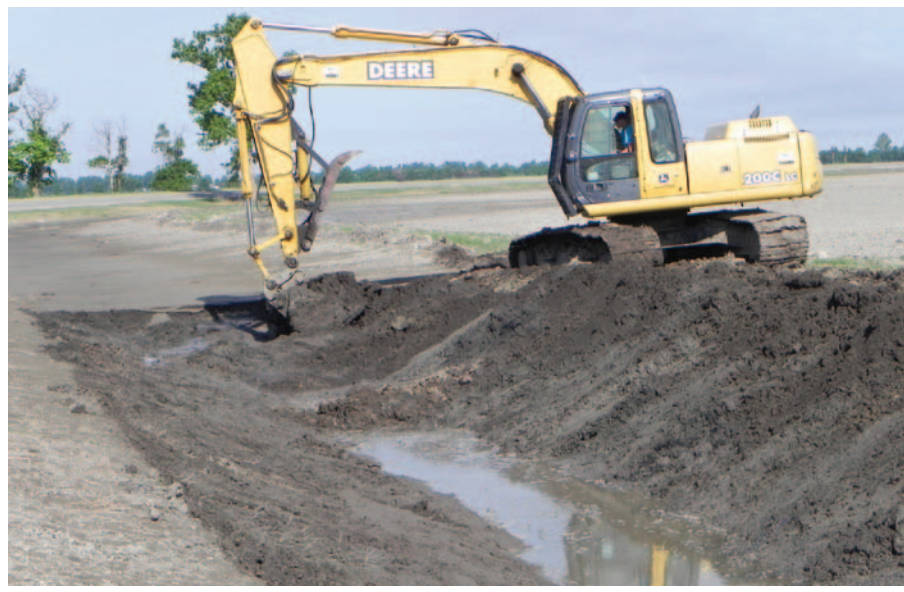
**Figure 3**

**Excavator cleaning out sediment in road ditches. Photo courtesy of Brett Miller, Soil Conservation Technician, USDA Natural Resources Conservation Service.**

The road and drainage ditches along Highway 77 in Mississippi County approximately 4 to 6 km (2.5 to 3.7 mi) south of Wyatt, Missouri, were filled with 0.9 to 1.8 m (3 to 6 ft) of sediment and sand. Figure 3 shows an excavator removing about 1.2 m (4 ft) of sediment from the road ditch. Irrigation systems were occasionally overturned by the force of water and wind and then buried by deltaic sand deposits (figure 4).

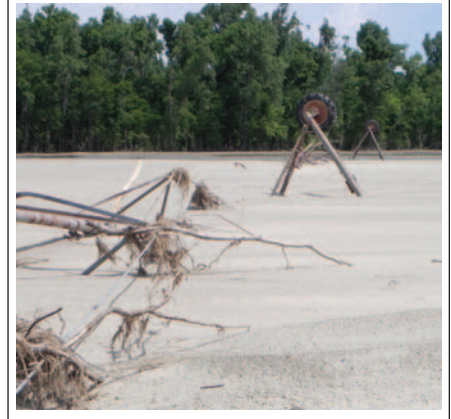
**Figure 4**  
An irrigation system was overturned by the force of floodwater and wind and then buried by thick sand deposit. Photo courtesy of Brett Miller, Soil Conservation Technician, USDA Natural Resources Conservation Service.

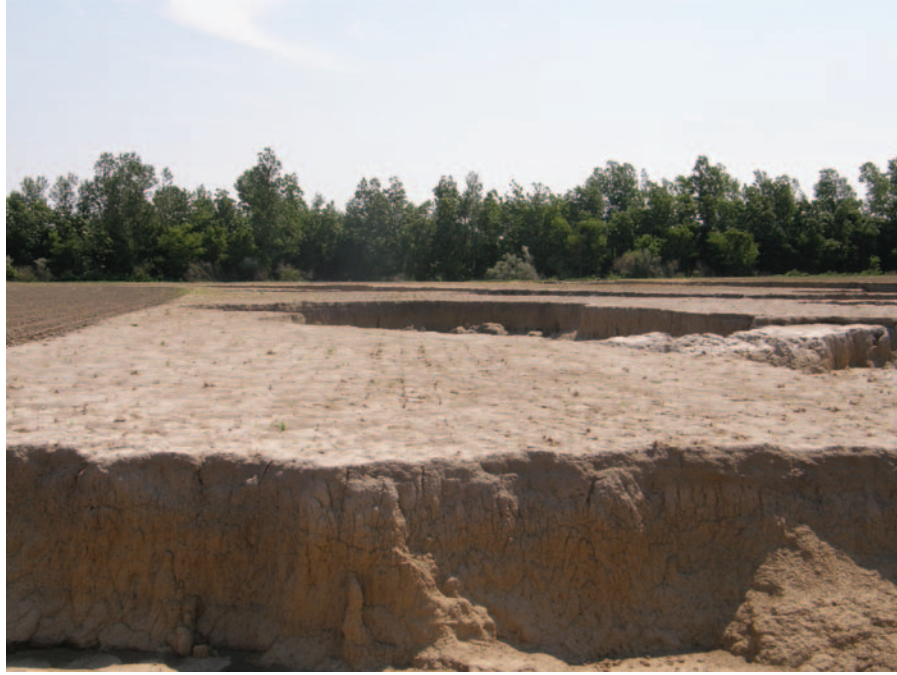
**Figure 5**

Gullies extended into cropland. The soybean stem and roots can be seen between the gullies. The gullies were created during the use of the Floodway in May 2011.

These gully lands will be extremely difficult to reclaim, and it is not clear how the land can be fully restored. The total amount of soil loss in metric tons has not been calculated, and the source of replacement soil will be difficult and costly to locate. Another option would be to regrade the vertical walls and reshape the fields with gullies into smooth rolling lands by filling in deepest craters with soil from the side slopes and crater walls. The new soils would be less productive than the previous alluvial soils (Olson and Lang 2000) due to the lower soil organic carbon content, greater slope, and lack of topsoil and subsoil material in the root zone. There is a health concern related to any pollutants that might be in floodwaters, such as untreated sewage from plants that were flooded or other chemicals picked up by floodwaters. When the organic and clay particles coating the plants and soils are dried, it is likely that sunlight will kill pathogens that might be present. Tillage could be used to bury or mix this potentially toxic coating into the topsoil layer, which will treat or dilute any toxic chemicals present. It is not known whether the soil organic carbon content of the alluvial soils would be increased as a result of sediment and exposure to carbon rich floodwater. It is anticipated that microbes will decompose the carbon deposited with the sediment or in the thin surface coating and release the carbon to the atmosphere as either carbon dioxide or methane gases, depending on whether there are aerobic or anaerobic conditions at the time the microbes are active.

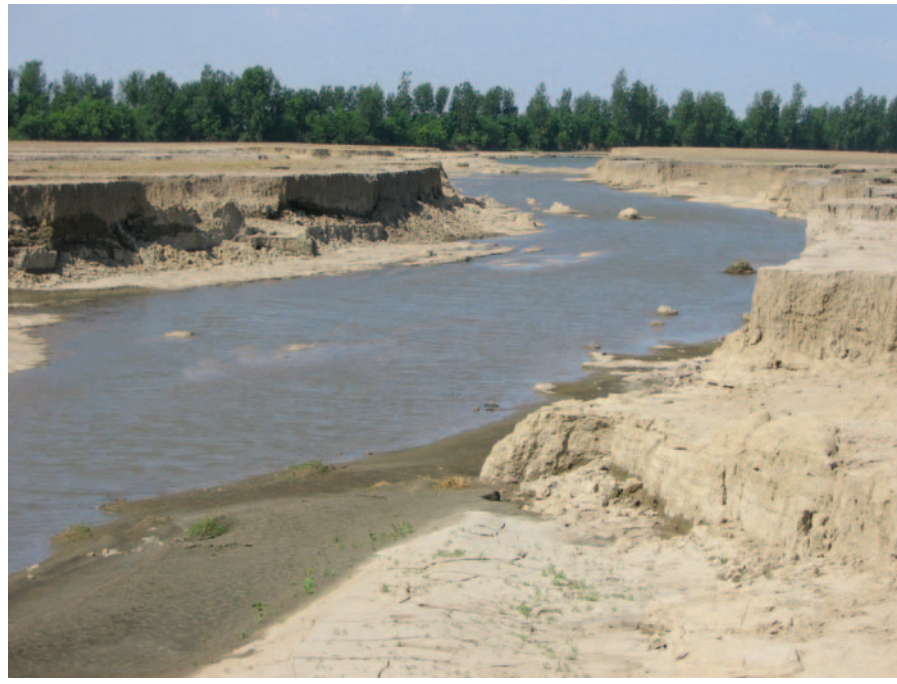
**Figure 6**

Gullies and channels that were created from May 4 to 16, 2011. The main channel and attached gullies were 3.7 m deep and removed more than 4 ha of cropland with an additional 4 ha of dissected field which could not be cultivated.

next to the levee breaches. Some of the gullies are 3.7 m (12 ft) deep, 45.8 m (150 ft) wide, and 1 km (0.6 mi) long (figure 6). A number of fields have these gullies, and

sometimes less than one-half of each field was planted to soybeans in June 2011. The force of water which created these large gullies (approaching small canyons in size)

also removed road beds and resulted in the loss of bridges.

fields with large and deep gullies will not easily be repaired. It will be rather difficult to reshape and regrade these gullies in isolated cultivated fields on ridges or second bottom soils. These fields of gullies could cause the permanent loss of agricultural land unless a federally funded land reclamation program is developed. Even if the fields of gullies are reclaimed, these soils are likely to have lower productivity. In many cases, the alluvial parent material will become the land surface and will have less soil aggregation, have less soil organic carbon, and be more sloping. The reclamation effort could restore some of the permanently lost cropland in crater lakes and sand delta and/or create additional wetlands and wildlife habitat adjacent to the patched levees.
