The impacts of 2011 induced levee breaches on agricultural lands of Mississippi River Valley

Kenneth R. Olson and Lois Wright Morton

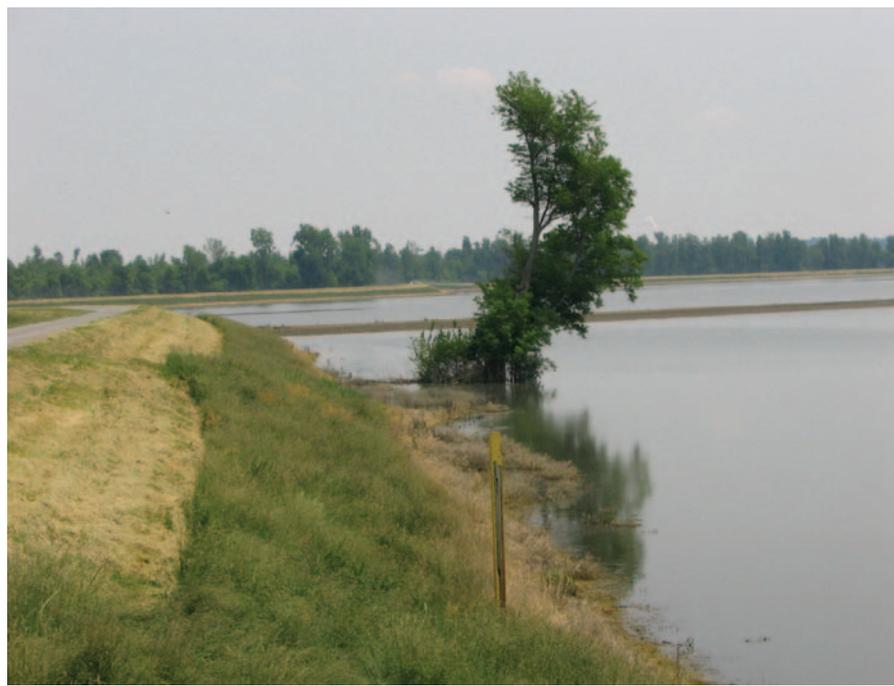
Figure 2

The New Madrid Floodway and Basin still has 2 to 3 m of floodwater on May 20, 2011.

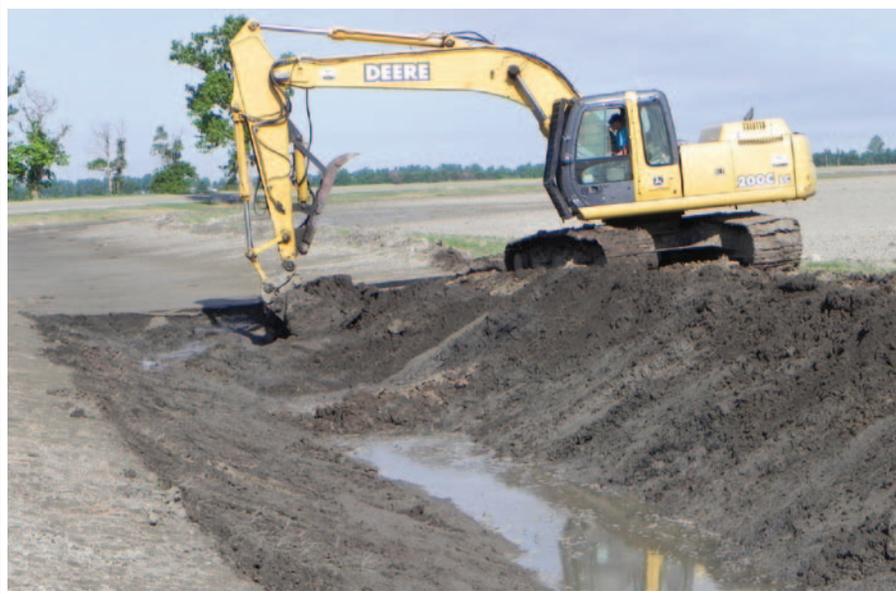
Excavator cleaning out sediment in road ditches. Photo courtesy of Brett Miller, Soil Conservation Technician, USDA Natural Resources Conservation Service.

The road and drainage ditches along Highway 77 in Mississippi County approximately 4 to 6 km (2.5 to 3.7 mi) south of Wyatt, Missouri, were filled with 0.9 to 1.8 m (3 to 6 ft) of sediment and sand. Figure 3 shows an excavator removing about 1.2 m (4 ft) of sediment from the road ditch. Irrigation systems were occasionally overturned by the force of water and wind and then buried by deltaic sand deposits (figure 4).

There could be a permanent loss of some agricultural production on hundreds of hectares (hundreds of acres) of land due to large deep gullies, on those parcels adjacent to the blown levees that are covered with a thick sand deposit, and on farmland that is now in the new crater lakes. Reclamation efforts by the US Army Corps of Engineers have removed much of the thick sand deposits, and the sand was used to patch the frontline and fuse plug levees between Birds Point, Missouri, and New Madrid, Missouri, or to partially fill in the crater lakes and adjacent gullies. Filled crater lakes at Birds Point have been covered with topsoil trucked in from outside the Floodway. The earthen levee was initially rebuilt to 15.6 m (51 ft) (fuse plug was previously at 18.4 m [60.5 ft] and frontline levee at 19.1 m [62.5 ft]), but after input from the local farmers and additional federal funding, the rebuilt levee was raised to 16.8 m (55 ft). Most of the drainage and road ditches which were filled with sediment were cleaned out by excavators prior to October of 2011 and proper drainage was restored. However, the unanticipated

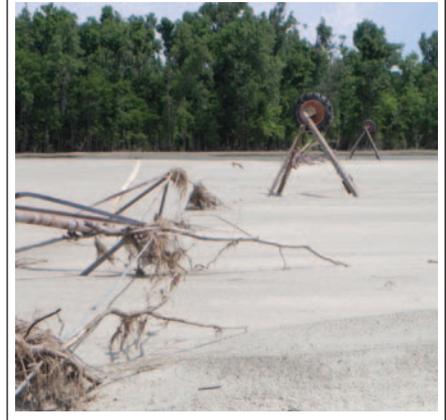
Figure 4
An irrigation system was overturned by the force of floodwater and wind and then buried by thick sand deposit. Photo courtesy of Brett Miller, Soil Conservation Technician, USDA Natural Resources Conservation Service.

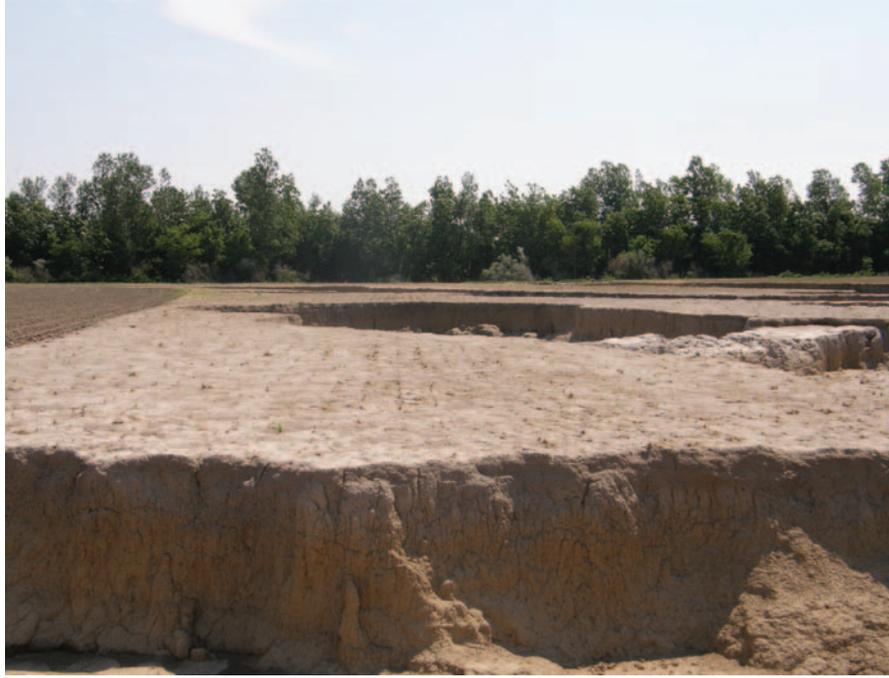
Figure 5

Gullies extended into cropland. The soybean stem and roots can be seen between the gullies. The gullies were created during the use of the Floodway in May 2011.

These gully lands will be extremely difficult to reclaim, and it is not clear how the land can be fully restored. The total amount of soil loss in metric tons has not been calculated, and the source of replacement soil will be difficult and costly to locate. Another option would be to regrade the vertical walls and reshape the fields with gullies into smooth rolling lands by filling in deepest craters with soil from the side slopes and crater walls. The new soils would be less productive than the previous alluvial soils (Olson and Lang 2000) due to the lower soil organic carbon content, greater slope, and lack of topsoil and subsoil material in the root zone. There is a health concern related to any pollutants that might be in floodwaters, such as untreated sewage from plants that were flooded or other chemicals picked up by floodwaters. When the organic and clay particles coating the plants and soils are dried, it is likely that sunlight will kill pathogens that might be present. Tillage could be used to bury or mix this potentially toxic coating into the topsoil layer, which will treat or dilute any toxic chemicals present. It is not known whether the soil organic carbon content of the alluvial soils would be increased as a result of sediment and exposure to carbon rich floodwater. It is anticipated that microbes will decompose the carbon deposited with the sediment or in the thin surface coating and release the carbon to the atmosphere as either carbon dioxide or methane gases, depending on whether there are aerobic or anaerobic conditions at the time the microbes are active.

fields with large and deep gullies will not easily be repaired. It will be rather difficult to reshape and regrade these gullies in isolated cultivated fields on ridges or second bottom soils. These fields of gullies could cause the permanent loss of agricultural land unless a federally funded land reclamation program is developed. Even if the fields of gullies are reclaimed, these soils are likely to have lower productivity. In many cases, the alluvial parent material will become the land surface and will have less soil aggregation, have less soil organic carbon, and be more sloping. The reclamation effort could restore some of the permanently lost cropland in crater lakes and sand delta and/or create additional wetlands and wildlife habitat adjacent to the patched levees.

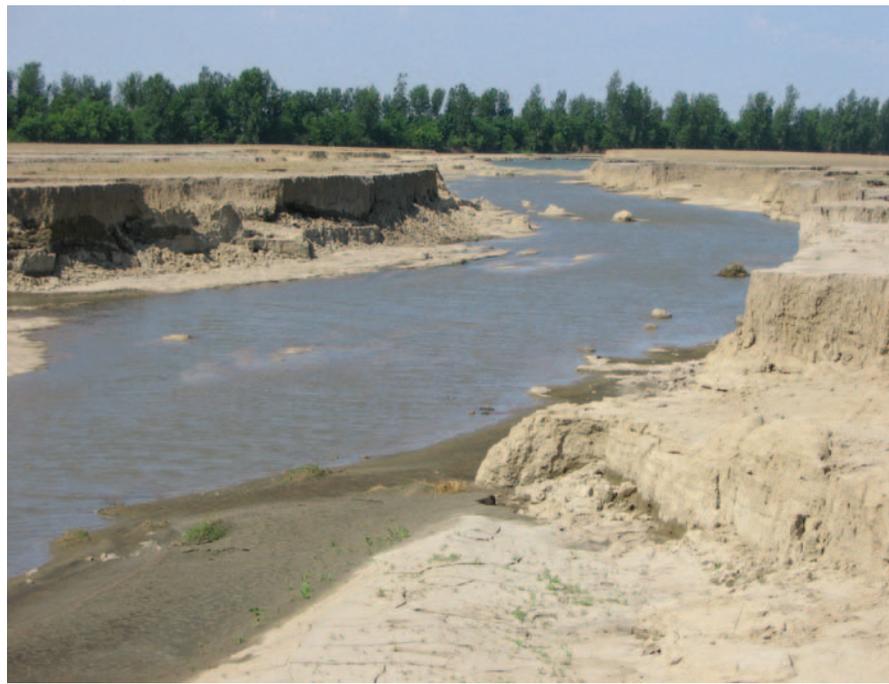
Figure 6

Gullies and channels that were created from May 4 to 16, 2011. The main channel and attached gullies were 3.7 m deep and removed more than 4 ha of cropland with an additional 4 ha of dissected field which could not be cultivated.

next to the levee breaches. Some of the gullies are 3.7 m (12 ft) deep, 45.8 m (150 ft) wide, and 1 km (0.6 mi) long (figure 6). A number of fields have these gullies, and
