The impacts of 2011 induced levee breaches on agricultural lands of Mississippi River Valley

Kenneth R. Olson and Lois Wright Morton

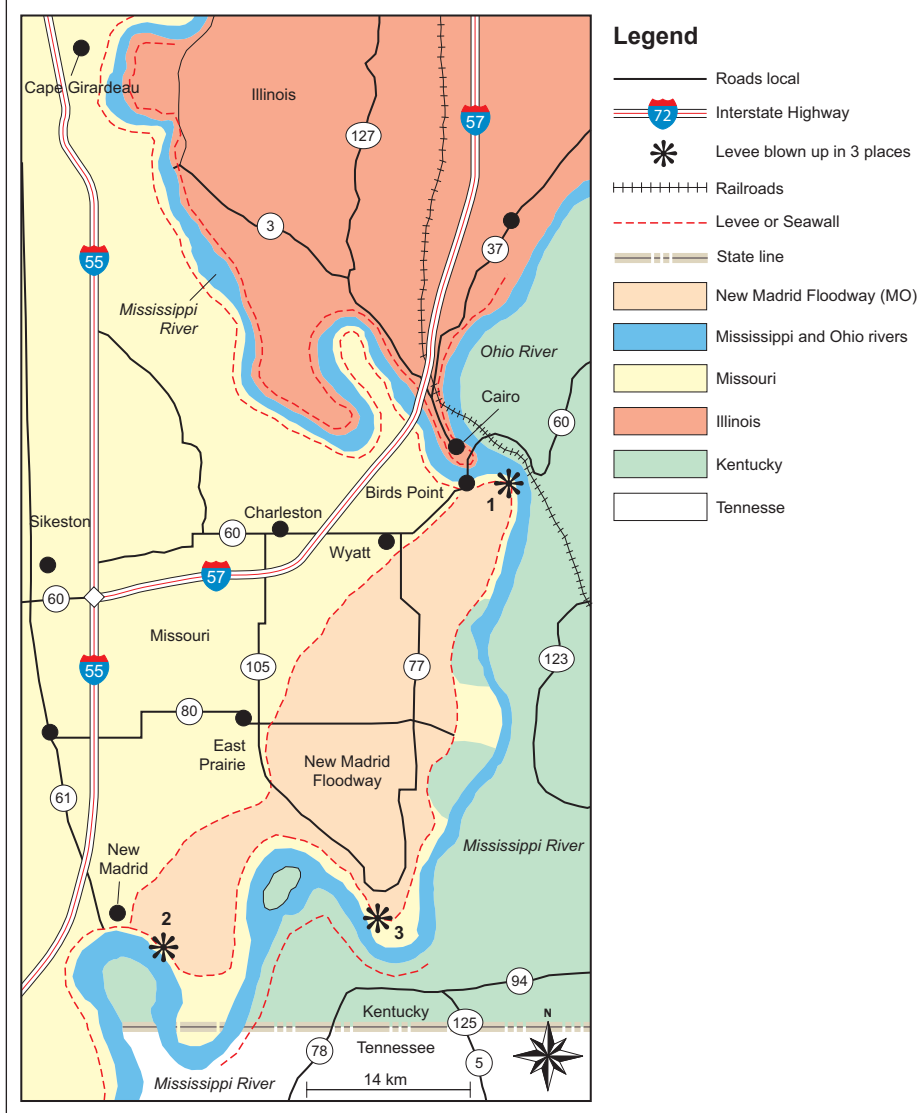
Figure 1

Map of the Ohio and Mississippi River confluence and Mississippi River from Cairo, Illinois, to New Madrid, Missouri.

back levee is 57.9 km (36 mi) long and goes from Birds Point, Missouri, to New Madrid, Missouri (figure 1). The USACE obtained easements in 1928 with the land owners on the 53,824 ha (133,000 ac) of the New Madrid Floodway, which gave them the right to pass floodwater into and through the New Madrid Floodway and temporarily store floodwater in the basin.

The induced breach at Birds Point, Missouri, the first explosion site (figure 1) and flooding of the New Madrid Floodway and basin on May 2, 2011, resulted in no loss of life thanks in part to the US National Guard sweep of the area to make sure the people living and working in the Floodway were evacuated. The force and impact of the floodwater on the 470 km² (208 mi²) of the Floodway may have been greater than projected in the 1983 Corps of Engineers operational plan. The Floodway was subjected to rapidly moving floodwaters which were initially 1.2 m (4 ft) deeper than would have been released if the fuse plug was blown when the Cairo levee was at 17.7 m (58 ft). There was severe damage to most of the 200 or more buildings, including homes, which were exposed to 0.9 to 1.8 m (3 to 6 ft) of flowing water and then partially submerged in 1.8 to 3 m (6 to 10 ft) of floodwater. Water pressure caused loss of the lower one-third to one-half of entire walls, damaged most wooden floors, and in some cases completely destroyed structures.

On May 3, 2011, the lower plug levee was blown up near New Madrid, Missouri, the second explosion site (figure 1) to begin the return of the stored floodwater back into the Mississippi River (figure 1). However, the Mississippi River was still too high to allow a quick drop in the floodwater in the New Madrid Floodway. The USACE planned to blow up the frontline levee near Big Oak Tree State Park in Missouri, the third explosion site (figure 1), on May 4, 2011, but weather and shortage of TNT delayed the third explosion until May 5, 2011. It appears for the next few days that the Mississippi River floodwater at the third breached levee site actually flowed out for days before it

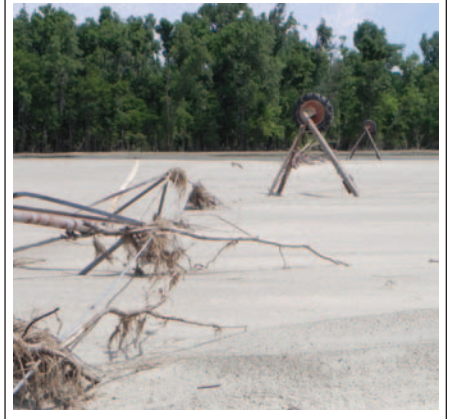
Figure 4

An irrigation system was overturned by the force of floodwater and wind and then buried by thick sand deposit. Photo courtesy of Brett Miller, Soil Conservation Technician, USDA Natural Resources Conservation Service.

The road and drainage ditches along Highway 77 in Mississippi County approximately 4 to 6 km (2.5 to 3.7 mi) south of Wyatt, Missouri, were filled with 0.9 to 1.8 m (3 to 6 ft) of sediment and sand. Figure 3 shows an excavator removing about 1.2 m (4 ft) of sediment from the road ditch. Irrigation systems were occasionally overturned by the force of water and wind and then buried by deltaic sand deposits (figure 4).

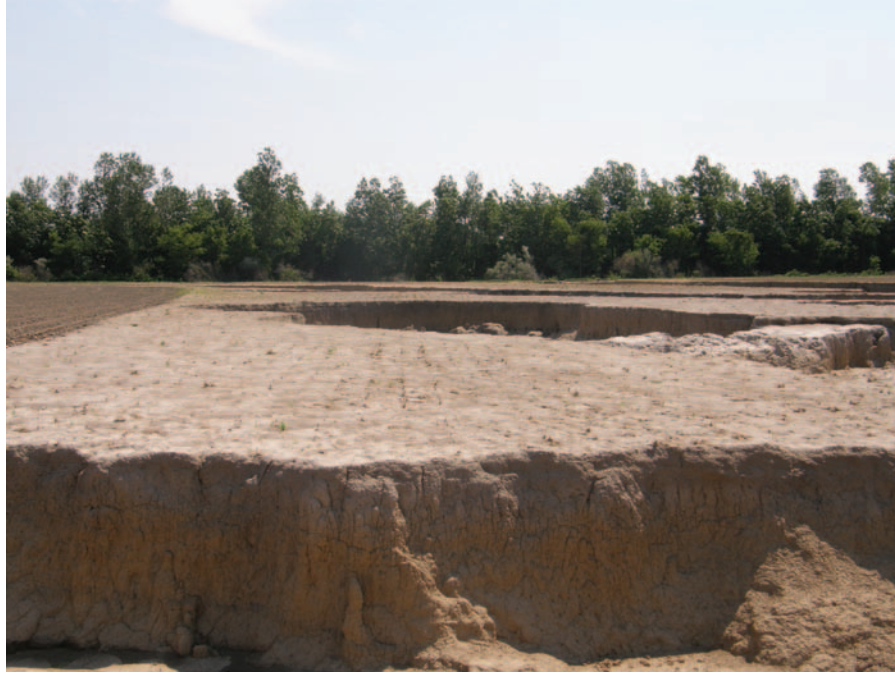
Figure 5

Gullies extended into cropland. The soybean stem and roots can be seen between the gullies. The gullies were created during the use of the Floodway in May 2011.

These gully lands will be extremely difficult to reclaim, and it is not clear how the land can be fully restored. The total amount of soil loss in metric tons has not been calculated, and the source of replacement soil will be difficult and costly to locate. Another option would be to regrade the vertical walls and reshape the fields with gullies into smooth rolling lands by filling in deepest craters with soil from the side slopes and crater walls. The new soils would be less productive than the previous alluvial soils (Olson and Lang 2000) due to the lower soil organic carbon content, greater slope, and lack of topsoil and subsoil material in the root zone. There is a health concern related to any pollutants that might be in floodwaters, such as untreated sewage from plants that were flooded or other chemicals picked up by floodwaters. When the organic and clay particles coating the plants and soils are dried, it is likely that sunlight will kill pathogens that might be present. Tillage could be used to bury or mix this potentially toxic coating into the topsoil layer, which will treat or dilute any toxic chemicals present. It is not known whether the soil organic carbon content of the alluvial soils would be increased as a result of sediment and exposure to carbon rich floodwater. It is anticipated that microbes will decompose the carbon deposited with the sediment or in the thin surface coating and release the carbon to the atmosphere as either carbon dioxide or methane gases, depending on whether there are aerobic or anaerobic conditions at the time the microbes are active.

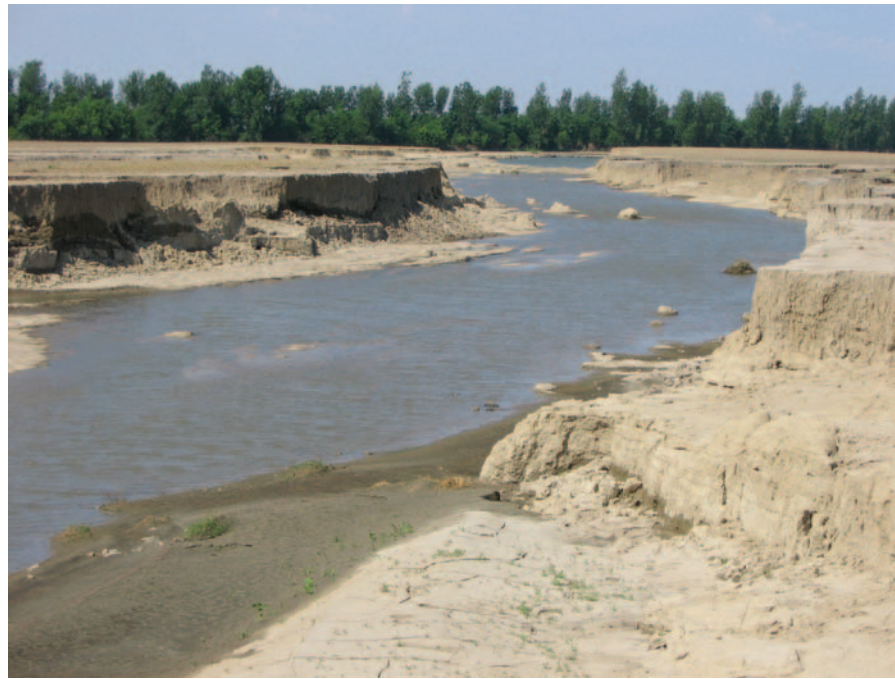
Figure 6

Gullies and channels that were created from May 4 to 16, 2011. The main channel and attached gullies were 3.7 m deep and removed more than 4 ha of cropland with an additional 4 ha of dissected field which could not be cultivated.

next to the levee breaches. Some of the gullies are 3.7 m (12 ft) deep, 45.8 m (150 ft) wide, and 1 km (0.6 mi) long (figure 6). A number of fields have these gullies, and
