The effects of 2011 Ohio and Mississippi river valley flooding on Cairo, Illinois, area

Kenneth R. Olson and Lois Wright Morton

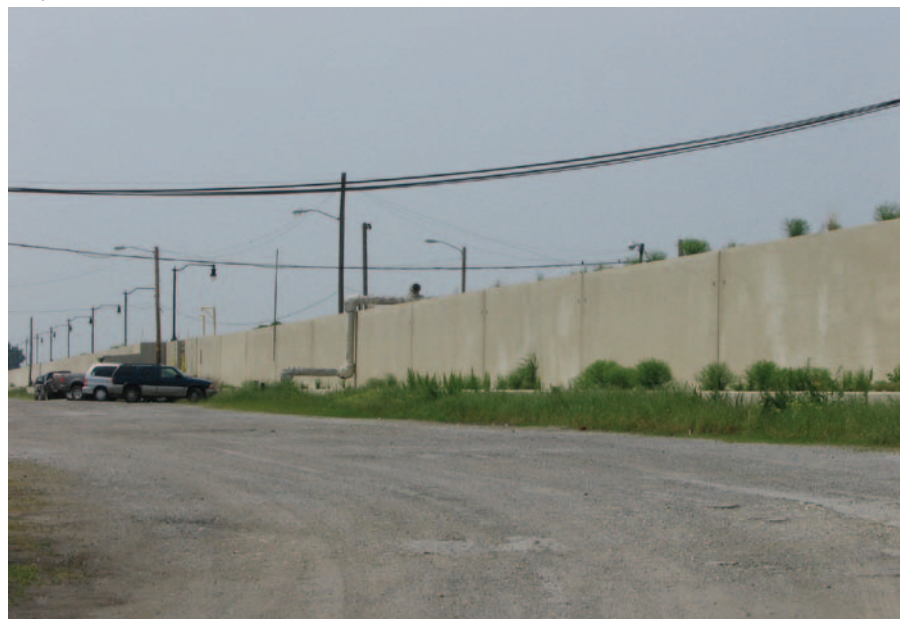
Figure 2

The Cairo seawall is on the Ohio River side at the bend where an earthen levee would be difficult to maintain. Factory worker vehicles are parked next to the seawall on May 20, 2011.

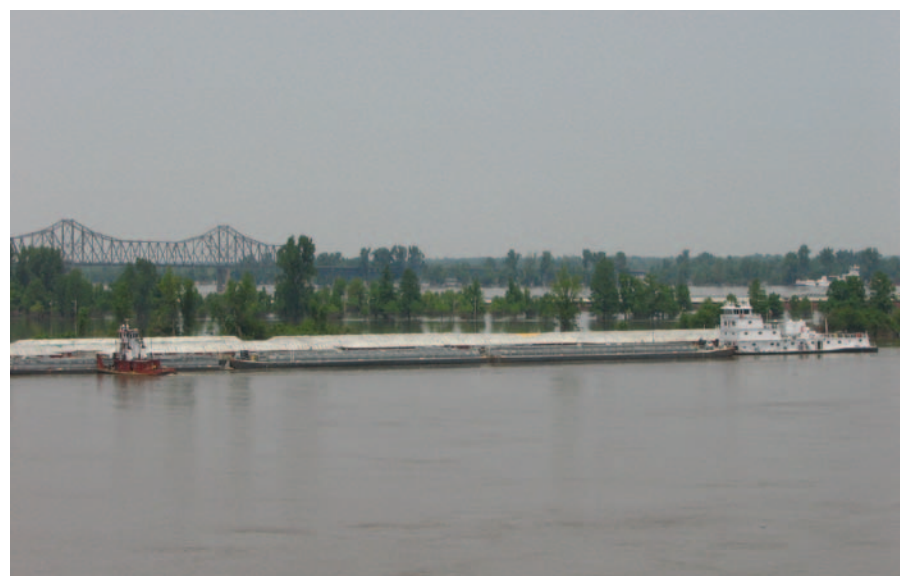
Figure 3

The Fort Defiance State Park trees are under water at the southernmost point of Illinois. The park is located south of Cairo levees and seawall and at the confluence of the Ohio (on the background) and Mississippi (on the foreground) rivers.

The Fort Defiance State Park (figure 3) is located just south of Cairo, Illinois, between the southernmost point of the Cairo levee and seawall system and the confluence of the Ohio and Mississippi rivers (figure 1). The park is the lowest point in the state of Illinois, with an elevation of 85

m (279 ft), and was under water once the Ohio and Mississippi rivers reached flood stage in early April of 2011 and stayed under water for almost two months. The 200 ha (500 ac) of Illinois farmland with Tice silty clay loam and Gorham silty clay loam soils (Parks and Fehrenbacher 1968)

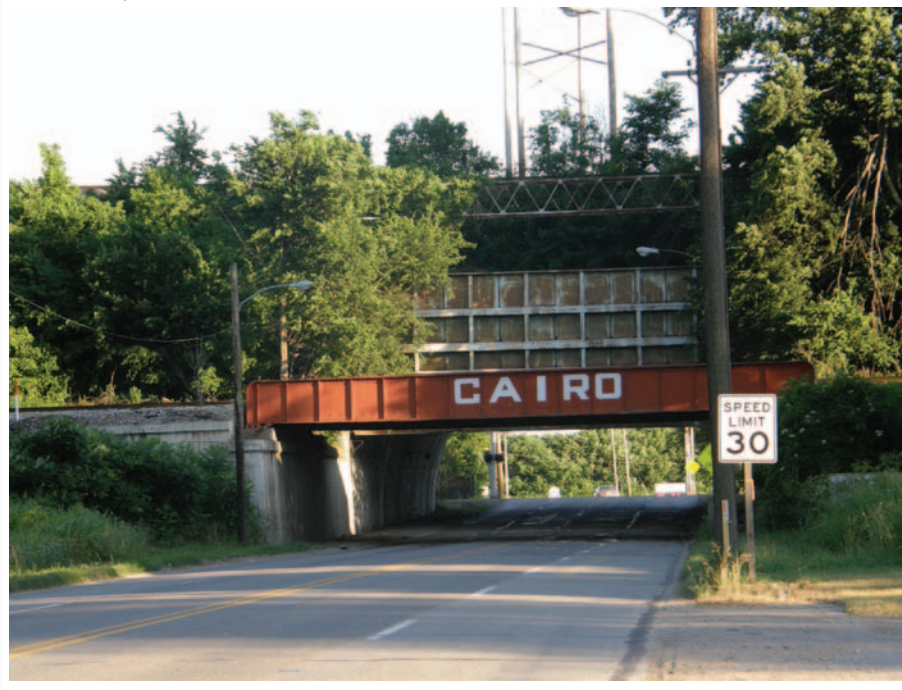
Figure 4

The raised railroad bed serves as the northern boundary of Cairo, Illinois, and provides an entry to the levee enclosed city for IL Route 3 traffic. Flood gates on this entry could seal the city behind embankments and seawall.

The city of Cairo is only 518 ha (1,280 ac) in size, and, if the levee system were to fail, it is estimated that more than 6.1 m (20 ft) depth of water would flow in rapidly and cover the city with 2,962 ha m (24,000 ac ft) of floodwater. The northern boundary of Cairo is two adjacent raised railroad beds (figure 4) that are 4.6 m (15 ft) and 12.2 m (40 ft) above Illinois Route 3 which passes underneath and through a tunnel. Between the raised railroad beds is a huge metal gate (figure 4), which can be lowered to block floodwaters from passing into Cairo from the north if the Cache River levee was to fail or be topped. During flood events, the entire city can be evacuated and sealed off from the floodwaters. If a levee or seawall system north of Cairo and on the Mississippi, Ohio, or Cache rivers failed, it would cause the flooding of Future City, Illinois, and the surrounding 809 ha (2,000 ac) of agricultural lands and cause the Cairo floodgate to be closed. The Future City area includes 1,214 ha (3,000 acres) of protected land (Tice silty clay loam, Riley silty clay loam, Darwin silty clay loam, and Cape and Karnak silty clay loam) (Parks and Fehrenbacher 1968) north of Cairo and south of Cache River levee. The Future City area has the capacity to provide an additional 1,214 ha (3,000 ac) of unintended floodwater storage if the Cache River levee break occurred and an additional 3,804 to 5,556 ha m (30,000 to 45,000 ac ft) of floodwater storage. This area, which is at a slightly higher elevation, could store water to a 3 to 4.6 m (10 to 15 ft) depth depending on location and also includes levee-protected Illinois farmland (Olson et al. 2011).

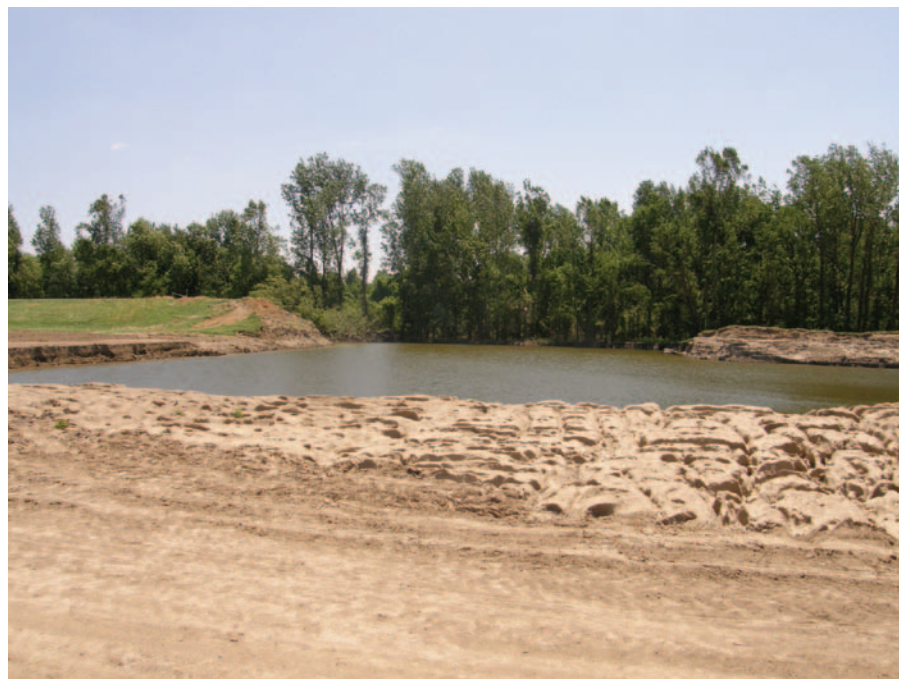
Figure 5

The Birds Point levee was the site of the first explosion and is visible with remnants of the fuse plug levee and the crater lake extending into the adjacent agricultural lands that are still under floodwaters.

exploded with a force of 3 on Richter scale. The Birds Point fuse plug levee from Tom Bird Blue Lake to 3 km (2 mi) to the south (figure 1) was opened in six places by this explosion, and the subsequent force of the rushing floodwater from the Mississippi River removed the adjacent sections of the degraded levee (Olson and Morton 2012). The USACE estimated that nearly one-fourth of the entire flow of the Mississippi River entered the New Madrid Floodway at the rate of $11,213 \text{ m}^3 \text{ s}^{-1}$ ($396,000 \text{ ft}^3 \text{ sec}^{-1}$). The diversion of the Mississippi River floodwater reduced the Cairo levee water level from 18.8 m (61.7 ft) to 18 m (59 ft) within 48 hours. The city of Cairo, Illinois, was spared from a natural seawall or levee breach or topping. Most residents returned by May 11, 2011, but were subjected to a nightly curfew. By then, the peak flow had dropped about 1.8 m (6 ft), and by May 20, 2011, life in Cairo was starting to return to normal and business activity picked up.

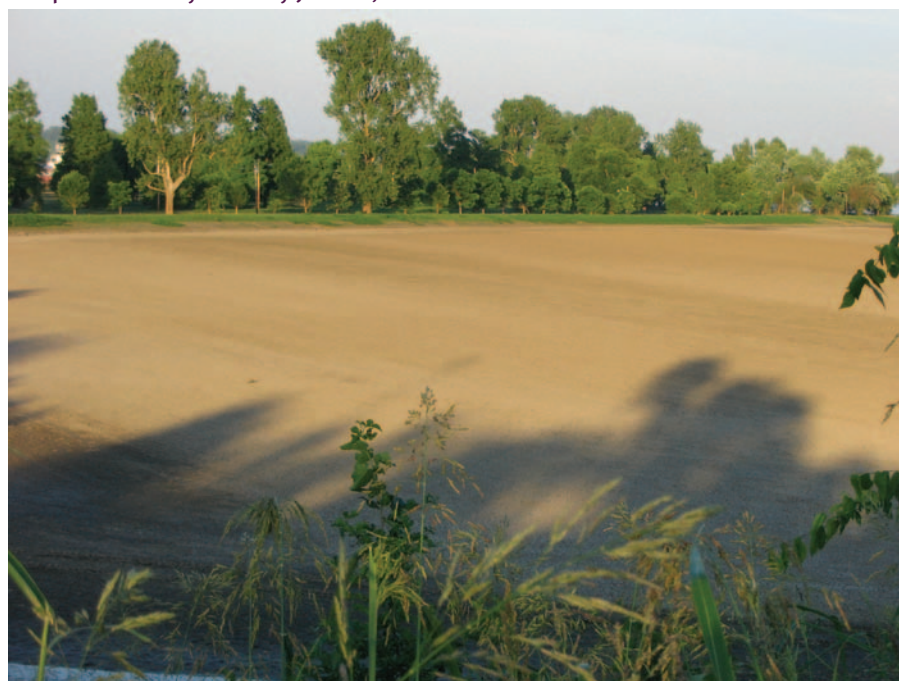
Figure 6

Fort Defiance State Park and adjacent Illinois agricultural land after Ohio River dropped and planted to soybeans by June 10, 2011.

The Illinois agricultural land inside the Cairo seawall and levee system was protected from flooding and there was no crop loss or soil damage. The Illinois cropland outside the levee was flooded before the 2011 crop was planted, and the water dropped sufficiently by June 10, 2011, to permit the planting of soybeans (figure 6). The impacts of the induced breach of the Birds Point levee on 53,824 ha (133,000 ac) of Missouri farmland in the Floodway resulted in the loss of 2011 crops and damage to future soil productivity. In the New Madrid Floodway, the strong current and sweep of water through the Birds Point breach created deep gullies, displaced tons of soil, and damaged irrigation equipment, farms, and home buildings (Olson and Morton 2012).
