# Soil and natural water contamination risk in the industrial area of Partizansk Coal-Burning Power Plant (south of the Russian Far East)

Alina V. Nazarkina, Olga D. Arefieva, Alla M. Derbentseva, and Valentina G. Tregubova

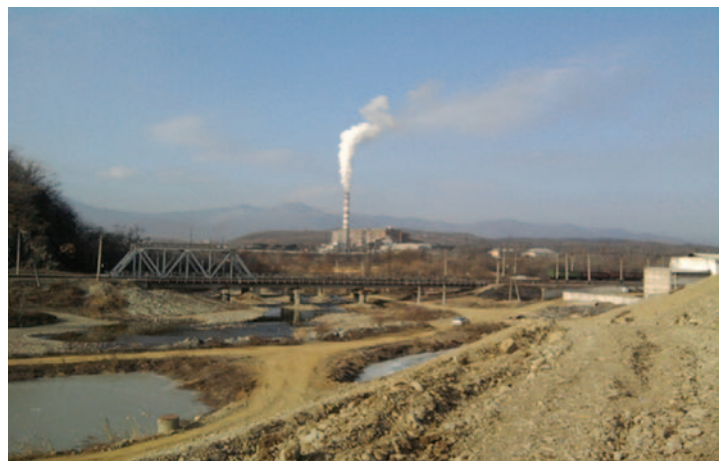
**Figure 2**

The industrial area of Partizansk Coal-Burning Power Plant.

One of the industrial structures in the area is the Partizansk Coal-Burning Power Plant (CBPP), operating since 1954 (figure 2). Due to the increase of power consumption in the southeast region of Primorskiy Krai by 4.7% to 6% each year, the plant was renovated in 2008 to 2009.
