Sinkholes and sand boils during 2011 record flooding in Cairo, Illinois

Lois Wright Morton and Kenneth R. Olson

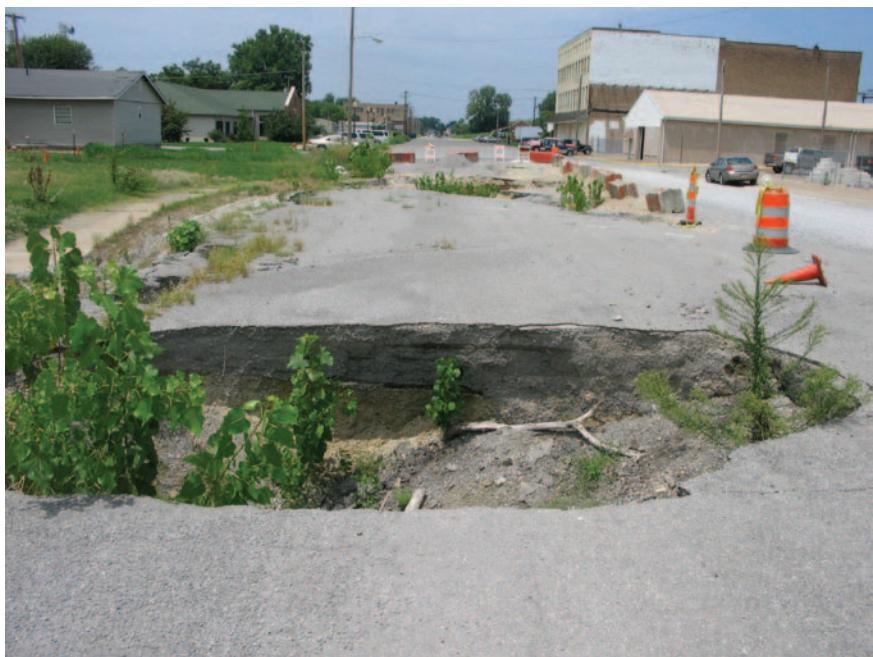
Figure 2

The Commerce Street sinkholes that are near or above the sanitary sewer lines.

A number of sinkholes also developed in late April and early May of 2011 in downtown Cairo on Commerce Street and 15th Street (figure 2). A sinkhole is a hole in the ground surface created by the collapse of overlying material as supporting material below the surface is eroded or piped by water (Veesaert 1990). Sinkholes have steep sides from the soil shearing as it collapses into the underlying void (Veesaert 1990).

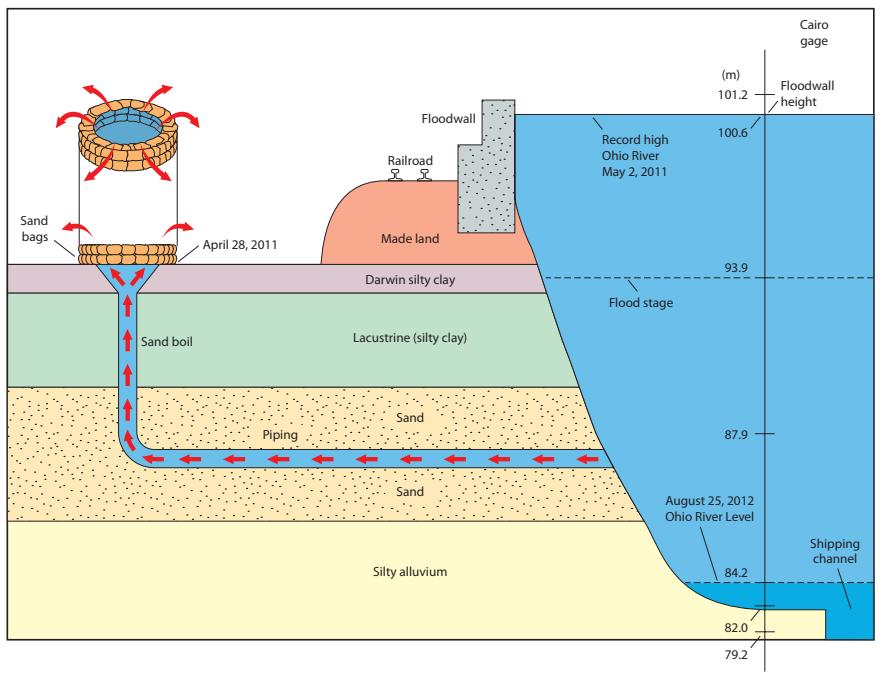
Figure 3

Diagram of sand boil at Cairo on April 28, 2011. The elevation of the highest flood level (101.2 m) of May 2, 2011, and the low drought level of August 25, 2012, are noted on Cairo gage. Diagram created by Mic Greenberg.

sand boils began appearing in Cairo. The first mega sand boil of the 2011 flood was found (Camillo 2012) by USACE beside a piezometer (a gauge which measures pressure of the groundwater) near 40th Street just south of the raised railroad bed and west of the water treatment plant (figure 1). A sand boil (figure 3) occurs when extreme water pressure against a levee leads to high hydraulic gradient conditions resulting in excessive seepage and piping of sediment exiting on the inside ground surface in a churning or boiling action (Veesaert 1990). Uncontrolled seepage is a major cause of levee failure, creating instability when high water pressure and saturation causes the earth materials to lose strength. A certain amount of under-

The sand boil occurred on Darwin silty clay loam soil (Parks and Fehrenbacher 1968), and on the evening of April 28, 2011, this high energy sand boil (figure 3) started to grow. In a few hours it enlarged dramatically from a few centimeters (few inches) to 0.6 m (2 ft) in diameter. The USACE quickly realized that this high energy sand boil had the potential to cause the Ohio River floodwall to fail at a time when 2,900 people were still in Cairo. The USACE decided that the traditional treatment of building a sand bag ring around the sand boil to keep water on the boil as a counter weight was insufficient and would not work this time. Instead they constructed a ring berm around the sand boil using a nearby stockpile of fly ash cinders (figure 4) owned by the Bunge Corporation (Camillo 2012). A bank of emergency lights were brought in as well as a bulldozer, backhoes, loader, excavators, dump trucks, and a crew of 40 to contain the large sand boil. The crew constructed a 15 m (50 ft) ring berm to a height of 2 m (6.6 ft). The sand boil continued to pipe sediment at an alarming rate. Since the city of Cairo still had many people who were not yet evacuated, the danger of the city being flooded with loss of life was a real concern. On May 2, 2011, after 48 hours of local rain, the fly ash cinders pile was turning to mush and had to be covered with a tarp (Camillo 2012). The fly ash cinder pile was then raised to 4 m (13.2 ft) (figure 4) to finally control the boil. This mega boil was among the most serious in the history of USACE use of earthen levees and floodwalls.

invested considerable resources to repair the sand boils and to reduce future risk of uncontrolled seepage underneath the floodwall, which undermines the levee system (figures 3 and 5). Repairing such boils can be complicated, with the possible approaches including relief wells, seepage berms, and cutoff walls, which involve digging a big trench and adding clay grout to cut off the leak (Koenig 2012). In October of 2012, the USACE began obtaining the rights to install 31 relief wells adjacent to the Cairo floodwall (figure 1) with construction completed by the fall of 2013.

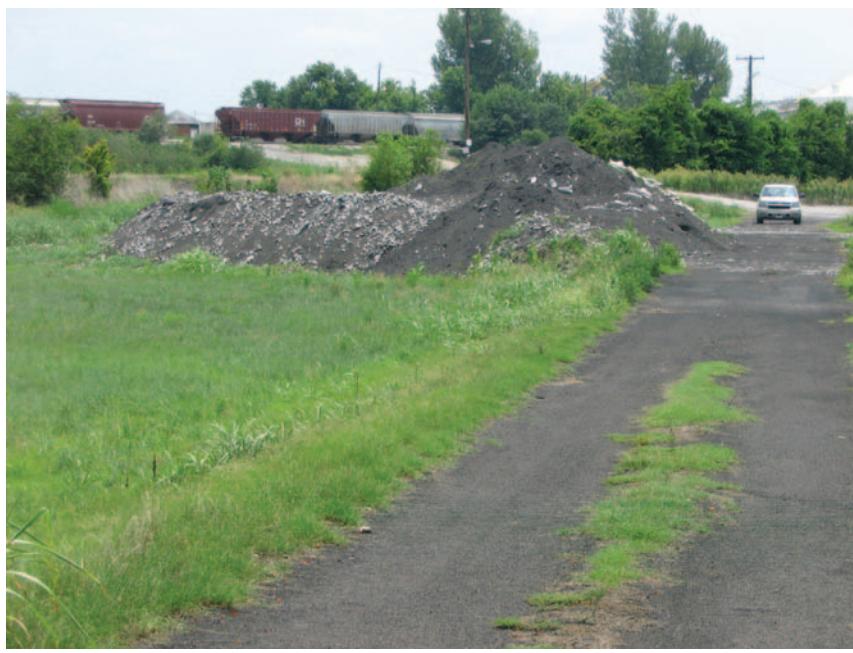
Figure 4

The 40th Street mega sand boil in Cairo near the water treatment plant and the raised railroad bed. The mega sand boil was filled in and covered with a 4 m high pile of fly ash cinders.

Sand boils, including a mega sand boil, occurred near the water treatment plant on 40th Street, revealing a weakening levee and floodwall system. The soil at the site of the mega sand boil was Darwin silty clay loam (Parks and Fehrenbacher 1968), which contains more than 40% clay in the upper 2 m (6.6 ft). Combined with the heavy local rains on May 1 and 2, the Cairo gage forecast was pushed to a peak of 19.4 m (63.5 ft) and placed additional pressure on these structures (Camillo 2012). These events were finally enough to convince the president of the Mississippi River Commission (MRC), Major General Michael Walsh (USACE), that the Birds Point-New Madrid Floodway had to be opened for the first time in 74 years.

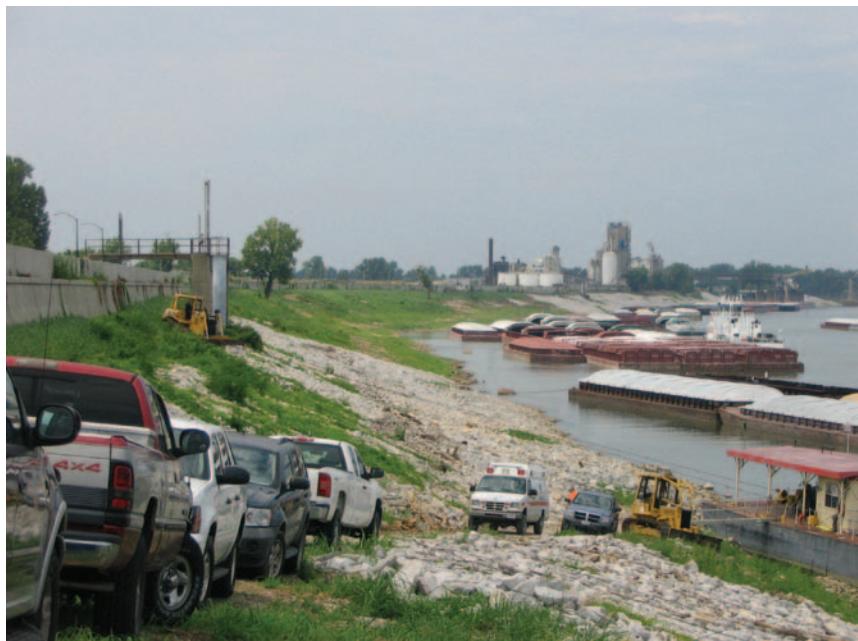
Figure 5

The 19.4 m Ohio River floodwall in August of 2012 when the Ohio River was at 3.6 m or 15.1 m lower than it was on May 2, 2011.

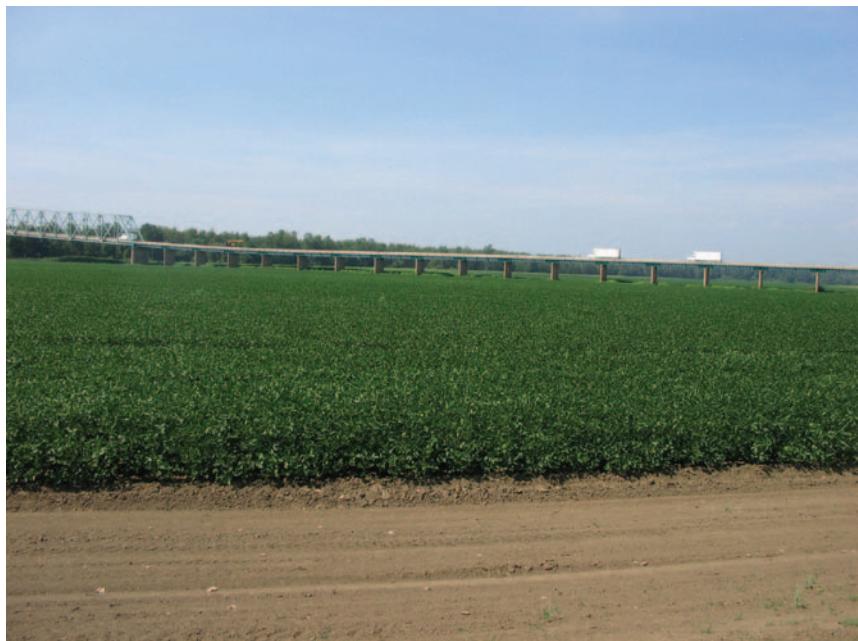
Figure 6

Soybean field located between the Upper Mississippi River and the Cairo, Illinois, levee. The US 60 bridge over the Mississippi River connects Illinois and Missouri.

loam soils (Parks and Fehrenbacher 1968) is located northwest of the Fort Defiance Park and between the Upper Mississippi River and the Cairo levee (figure 1). This farmland was under water for the entire months of April and May in 2011. After both the Ohio and Upper Mississippi rivers dropped and drained in early June of 2011, these fields were planted to soybean (*Glycine max* L.; figure 6). June is the normal planting time for soybean, so very little yield loss occurred. An additional 80 ha (200 ac) of alluvial land is mapped on the east side of the Upper Mississippi River (figure 1) and south of I-57. Only 10 ha (25 ac) are cultivated, and the other 70 ha (175 ac) remain in forest. All of the agricultural land was planted and harvested in 2011. No crop insurance benefits were paid to farmers in the area for flooding damage to the crop since there were no significant crop losses or yield reductions.

There were no visible signs of soil erosion or soil damage in these unleveed agricultural lands after the floodwaters receded in early June of 2011. Failed levees are the most common cause of significant soil erosion and soil damages in the form of crater lakes, gullies, and sand deltas (Olson and Morton 2012b, 2013b) along the Ohio and Mississippi rivers. During April of 2011, the slow rise in Ohio and Mississippi rivers covered unleveed farmland with floodwater that eventually reached depths of more than 6.7 m (22 ft). The floodwater left behind a thin silt and clay deposit on the agricultural lands and crop residue. These coatings include soil organic carbon (C), microbes, and pathogens. After the coating dried, they were incorporated into the topsoil layer of the alluvial soils using tillage equipment. The mixing in of sediment into the topsoil seemed to have resulted in little significant loss of soil productivity (Olson and Morton 2012b; 2013b).
