Slurry trenches and relief wells installed to strengthen Ohio and Mississippi river levee systems

Kenneth R. Olson and Lois Wright Morton

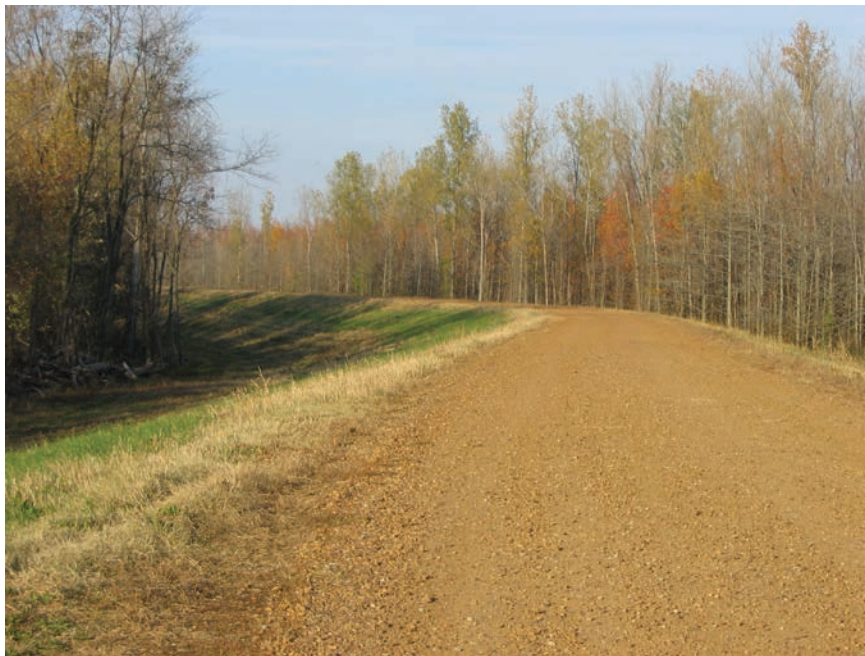
Figure 2

The leveed diversion which redirects the middle Cache River water into the Mississippi River and blocks it from draining into the Ohio River via the lower Cache River.

Approximately 405 ha (1,000 ac) of agricultural land north of the lower Cache River levee was flooded by the middle Cache River as a result of Mississippi River backing up through the diversion (figure 2) and blocking the westward flow of the middle Cache River. This caused a backup in the middle Cache River, which flooded the adjacent forest covered alluvial soils (e.g., Bonnie silt loam, wet; Piopolis silty clay loam, wet; and Karnak silty clay, wet) and flooded the slightly higher cultivated Petrolia silty clay loam and the Cape and Karnak silt loam soils. These cultivated soils drained by the middle of June of 2011 and were planted to soybeans (*Glycine max* L.) after the Ohio and Mississippi rivers dropped below flood stage.

High water levels in the spring of 2011 on the Ohio River caused the Upper Mississippi River near the confluence to back up for many kilometers (miles) to the north of Cairo. Floodwaters backed up into tributaries and through the diversion (figures 1 and 2), which blocked the drainage of local floodwaters from a heavy May rain. The record 18.7 m (61.7 ft) peak on the Ohio River at Cairo flood gage resulted in approximately 160 ha (400 ac) of alluvial land along the northeast side of the Upper Mississippi River (figure 1) between mile marker 8 and 12 being flooded. Approximately 40 ha (100 ac) had been cultivated, and the other 120 ha (300 ac) remained in forest. Alluvial land consists of recently deposited sediment that varies widely in texture (from clay to sand), and layers are commonly stratified. Detailed deposition, erosion, and channel separa-

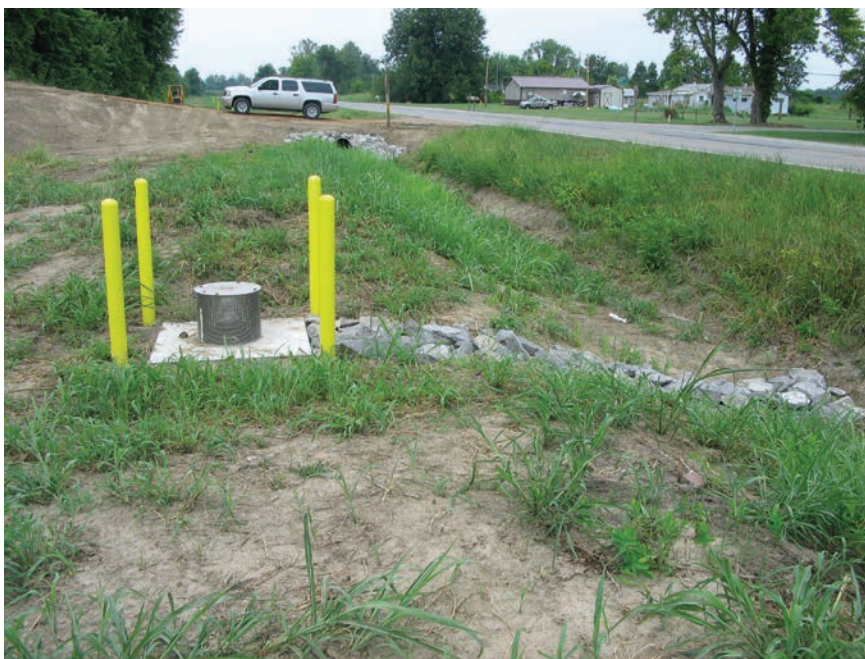
Figure 3

One of the 28 relief wells located between the Mississippi River levee and Route 3 just northeast of Cairo county airport.

wells, which drain into a Route 3 road ditch (figure 3), were constructed northeast of the Cairo airport and south of the Cache River levee. The relief wells were

built to reduce damaging uplift pressure from excessive seepage through pervious materials that were insufficient to block water flow under the levee (Vecesaert

1990). Relief wells control the pressure and are designed to help prevent piping of sediments, which is the real threat to levees and floodwalls (Morton and Olson 2015; Camillo 2012). These wells are designed to control the direction and quantity of seepage and together form a collection system to discharge water back into the Mississippi River (figure 4). Slurry trenches, typically 0.6 to 1.2 m (2 to 4 ft) wide and between 16 and 29 m (35 to 95 ft) deep are used to create an impervious barrier that cuts off the seepage flow and potential piping of sediment by water (Nemati 2007). They consist of Bentonite or drilling mud clays that are usually formed from volcanic mineral (Montmorillonite) clays and are available in powdered form which when added to water form a thick, sticky viscous fluid (Nemati 2007). The hydration of the clay particles causes them to bond and swell, forming a gel that can be poured into the slurry trench. Bentonite bags were brought in and mixed in slurry ponds (figure 5) for injection into 2,180 m (7,200 ft) of slurry trenches (figure 6) in an effort to reinforce the well and restrict the underground flow of water under the levee. The work on the Mississippi River slurry trenches was completed in November of 2012.

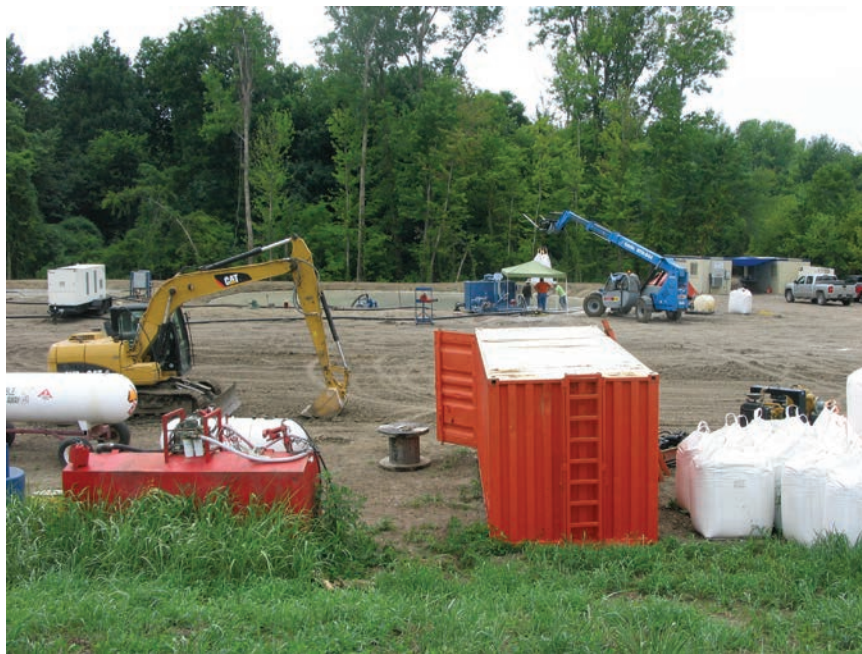
Figure 5

Two slurry ponds where the Bentonite bags were dumped and mixed with water to create slurry for the trench.

A 1,782 m (5,400 ft) slurry trench and two berms were added to the Ohio River levee system between Mound City and Cairo north of the Ohio River floodwall (figures 1, 5, and 6) east of Route 37 and south of the Cache River levee. These projects were designed to prevent seepage during future major flooding, and all work was completed by November of 2013. Another project flattened the slope on the Mississippi River levee and widened its crown. Improvements including work on pump stations, drainage systems, and small levees, some of which failed in April of 2011, were completed in the Cache River Valley area north of Cairo. These projects were funded by the county matching funds with the USACE and combinations of grants from the Delta Regional Authority and the state of Illinois (Koenig 2012). North of Cairo and south of the Cache River levee, the smaller towns such as Urbandale, Future City, and Klondike are now better protected from major flooding in the future.
