# Slurry trenches and relief wells installed to strengthen Ohio and Mississippi river levee systems

Kenneth R. Olson and Lois Wright Morton

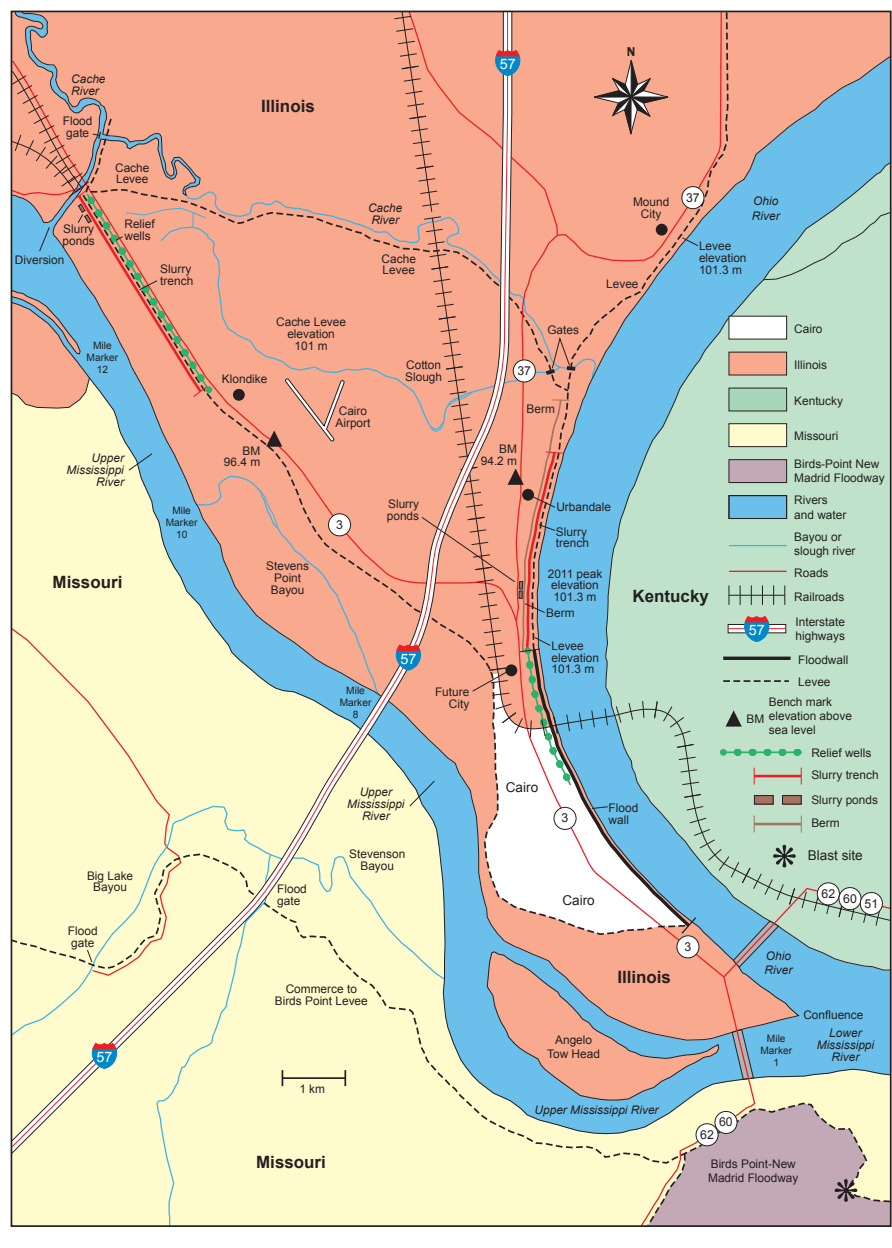
**Figure 1**

Map of the Ohio, Mississippi, and Cache river levees north of Cairo, Illinois, and south of the Cache River. Map by Mic Greenberg.

(3 to 5 mi) wide as a result of the previous river having been much larger when it carried waters from the ancient Ohio River Valley in addition to the local waters from the Cache River (figure 1).

The system of levees north of Cairo and south of Cache River levee (figure 1) on the Mississippi, Ohio, and Cache rivers protect three towns, the Cairo airport, and Illinois farmland (Olson and Morton 2013a, 2013b). Failure of any one of these levees would cause severe flooding of Urbandale, Klondike, and Future City, Illinois, and the surrounding 800 ha (2,000 ac) of agricultural lands, and cause the Cairo floodgate between raised railroad beds over Route 3 to be closed. This north of Cairo area includes 1,214 ha (3,000 ac) of levee-protected land (figure 2) with silty soils, (Tice silty clay loam, Riley silty clay loam, Darwin silty clay loam, and Cape and Karnak silty clay loam) (Parks and Fehrenbacher 1968) and is at a slightly higher elevation than the City of Cairo. Flooding would have caused significant loss of life and severe damage to buildings in the areas to the north of the City of Cairo. A levee breach could damage a hundred or more buildings in the Future City, Klondike, and Urbandale areas and require the local population to be evacuated.

damage in Klondike, Urbandale, and Future City and little flood damage to most of the 1,000 ha (2,500 ac) of agricultural land within the levee-protected area north of Cairo. However, there were approximately 100 ha (250 ac) that experienced some internal flooding from local rains (within the boundaries of the three levees, south of the Cache levee and north of the Cairo airport) that could not drain through the closed Cotton Slough (figure 1) gate on the Cache levee.

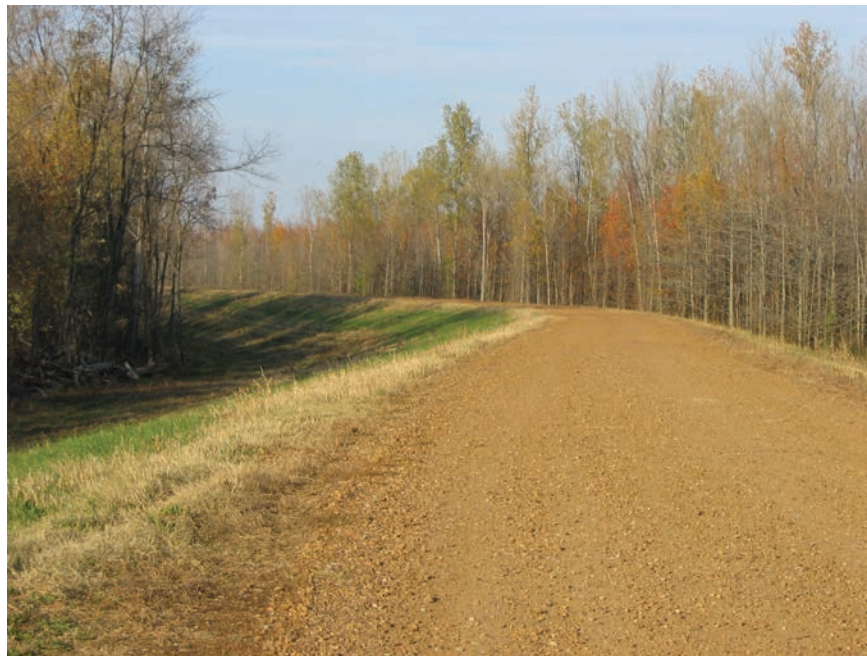
**Figure 2**

The leveed diversion which redirects the middle Cache River water into the Mississippi River and blocks it from draining into the Ohio River via the lower Cache River.

Approximately 405 ha (1,000 ac) of agricultural land north of the lower Cache River levee was flooded by the middle Cache River as a result of Mississippi River backing up through the diversion (figure 2) and blocking the westward flow of the middle Cache River. This caused a backup in the middle Cache River, which flooded the adjacent forest covered alluvial soils (e.g., Bonnie silt loam, wet; Piopolis silty clay loam, wet; and Karnak silty clay, wet) and flooded the slightly higher cultivated Petrolia silty clay loam and the Cape and Karnak silt loam soils. These cultivated soils drained by the middle of June of 2011 and were planted to soybeans (*Glycine max* L.) after the Ohio and Mississippi rivers dropped below flood stage.

High water levels in the spring of 2011 on the Ohio River caused the Upper Mississippi River near the confluence to back up for many kilometers (miles) to the north of Cairo. Floodwaters backed up into tributaries and through the diversion (figures 1 and 2), which blocked the drainage of local floodwaters from a heavy May rain. The record 18.7 m (61.7 ft) peak on the Ohio River at Cairo flood gage resulted in approximately 160 ha (400 ac) of alluvial land along the northeast side of the Upper Mississippi River (figure 1) between mile marker 8 and 12 being flooded. Approximately 40 ha (100 ac) had been cultivated, and the other 120 ha (300 ac) remained in forest. Alluvial land consists of recently deposited sediment that varies widely in texture (from clay to sand), and layers are commonly stratified. Detailed deposition, erosion, and channel separa-

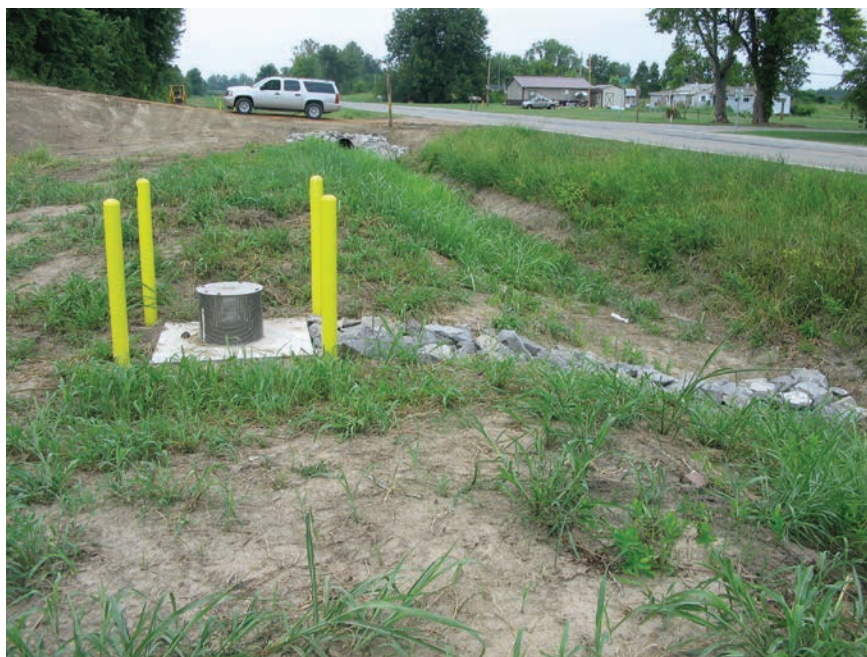
**Figure 3**

One of the 28 relief wells located between the Mississippi River levee and Route 3 just northeast of Cairo county airport.

wells, which drain into a Route 3 road ditch (figure 3), were constructed northeast of the Cairo airport and south of the Cache River levee. The relief wells were

built to reduce damaging uplift pressure from excessive seepage through pervious materials that were insufficient to block water flow under the levee (Vecesaert

1990). Relief wells control the pressure and are designed to help prevent piping of sediments, which is the real threat to levees and floodwalls (Morton and Olson 2015; Camillo 2012). These wells are designed to control the direction and quantity of seepage and together form a collection system to discharge water back into the Mississippi River (figure 4). Slurry trenches, typically 0.6 to 1.2 m (2 to 4 ft) wide and between 16 and 29 m (35 to 95 ft) deep are used to create an impervious barrier that cuts off the seepage flow and potential piping of sediment by water (Nemati 2007). They consist of Bentonite or drilling mud clays that are usually formed from volcanic mineral (Montmorillonite) clays and are available in powdered form which when added to water form a thick, sticky viscous fluid (Nemati 2007). The hydration of the clay particles causes them to bond and swell, forming a gel that can be poured into the slurry trench. Bentonite bags were brought in and mixed in slurry ponds (figure 5) for injection into 2,180 m (7,200 ft) of slurry trenches (figure 6) in an effort to reinforce the well and restrict the underground flow of water under the levee. The work on the Mississippi River slurry trenches was completed in November of 2012.

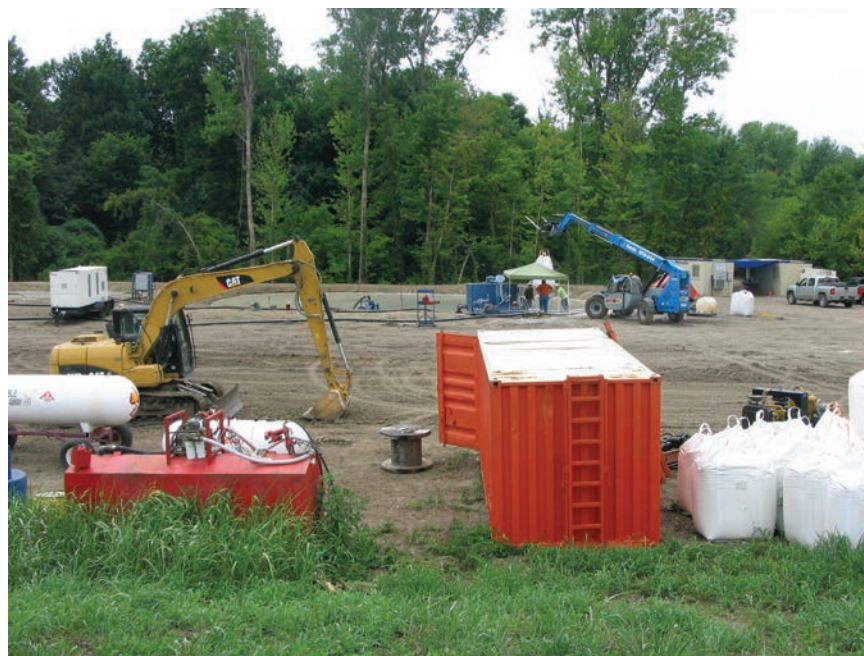
**Figure 5**

Two slurry ponds where the Bentonite bags were dumped and mixed with water to create slurry for the trench.

A 1,782 m (5,400 ft) slurry trench and two berms were added to the Ohio River levee system between Mound City and Cairo north of the Ohio River floodwall (figures 1, 5, and 6) east of Route 37 and south of the Cache River levee. These projects were designed to prevent seepage during future major flooding, and all work was completed by November of 2013. Another project flattened the slope on the Mississippi River levee and widened its crown. Improvements including work on pump stations, drainage systems, and small levees, some of which failed in April of 2011, were completed in the Cache River Valley area north of Cairo. These projects were funded by the county matching funds with the USACE and combinations of grants from the Delta Regional Authority and the state of Illinois (Koenig 2012). North of Cairo and south of the Cache River levee, the smaller towns such as Urbandale, Future City, and Klondike are now better protected from major flooding in the future.

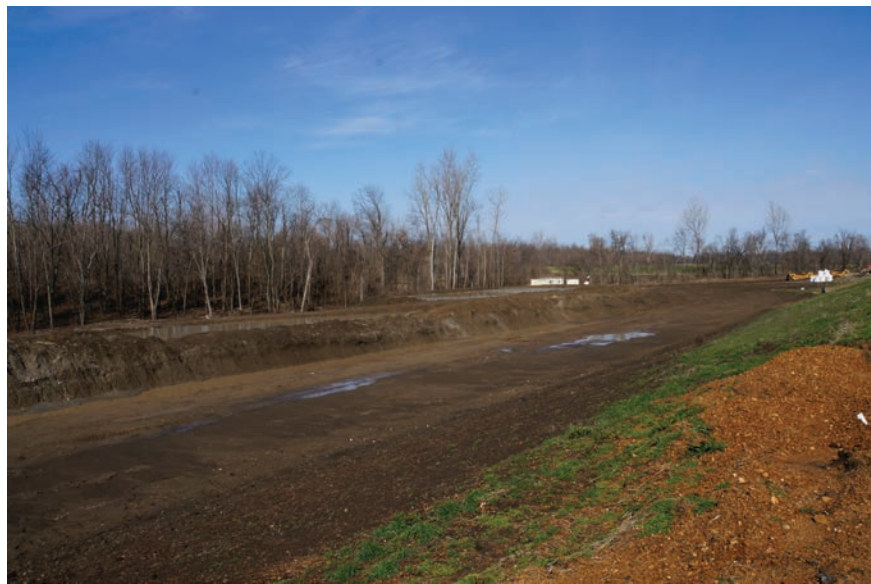
**Figure 6**

Slurry trench between the levee and Mississippi River.
