Mississippi River threatens to make Dogtooth Bend peninsula in Illinois an island

Kenneth R. Olson and Lois Wright Morton

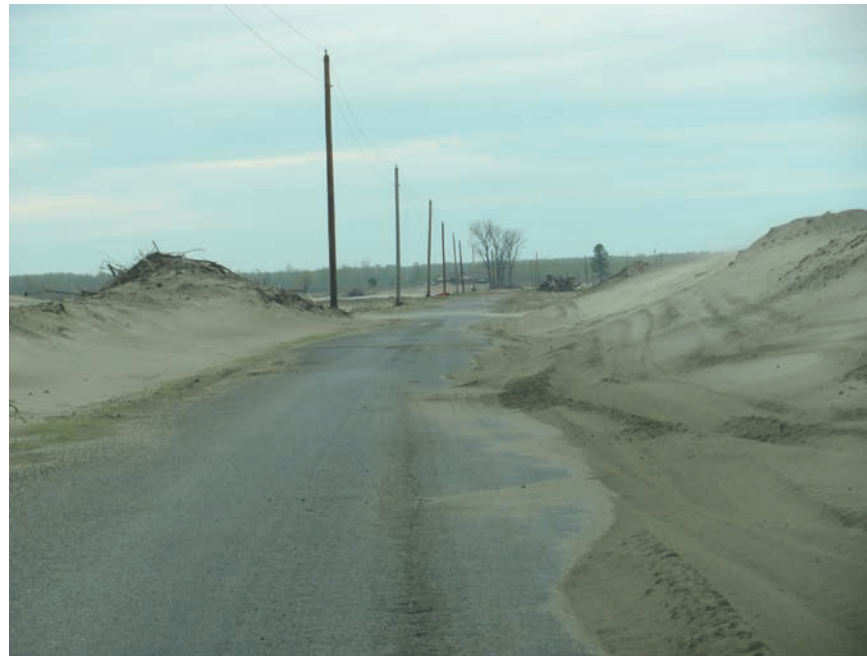
Figure 1

Mississippi River floodwaters deposited many tons of sand on farmland and roads in Dogtooth Bend peninsula when the Len Small levee breached in January of 2016. The sand dunes left behind required graders and snow plows to open the road for local traffic.

the Dogtooth Bend bottomlands along with millions of tons of sand deposited on more than 600 ha (1,500 ac) of farmland. Another 800 ha (2,000 ac) were subjected to land scouring by the Mississippi floodwaters. The county lost 11 to 13 km (7 to 8 mi) of roads with others buried by sand (figure 1). After ditches and culverts filled with sand, drainage was nearly impossible.

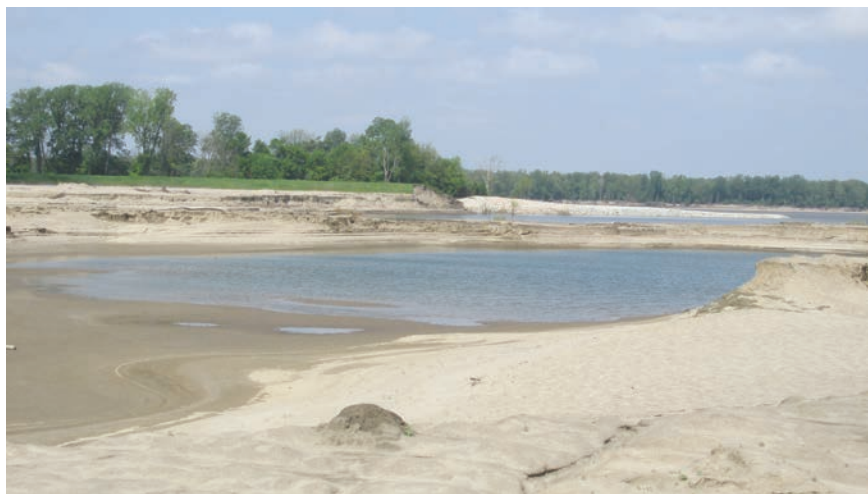
Figure 4

The 2016 Len Small levee breach was 1.6 km long. US Army Corps of Engineer crews, working from barges in the Mississippi River channel, dropped rocks in front of and against levee banks in an attempt to stabilize them. This rock barrier covering a portion of the south end of the levee breach is shown in the right side of picture.

The 2016 Len Small levee breach was much more severe than 2011 because of its location (figure 2). The fast moving river cut a 1.6 km (1 mi) long breach during late December of 2015 through early January of 2016 (figure 4) and scoured out a crater lake and deep gullies into adjacent agricultural lands. The southeast flow of the Mississippi River floodwaters through the breach created a new channel (figure 5) from river mile marker 34 through Alexander County, connected to an old meander channel, and then exited back into the main stem river at mile marker 15, a distance of 4.6 km (3.5 mi). This shortcut across Dogtooth Bend peninsula by-passed about 15 river miles (24 km) of the current Mississippi River path (figure 2). Approximately seven river lane-line buoys, hundreds of trees (figure 6), irrigation pivots, and other debris were carried onto

Following the January of 2016 winter flood, the USACE moved a large amount of rock in front of the 1,200 m (4,000 ft) breach (figure 4) in anticipation of spring floods to keep the Mississippi River from extending the 4.6 km (3.5 mi) channel to the next downstream bend in the Mississippi River. If the channel were to permanently cross Dogtooth Bend peninsula, it would become an island cutting off more than 6,000 ha (15,000 ac), at least one hunting structure, and one home from the Illinois mainland. The USACE conducted a sonar survey of the 2016 Len Small levee breach to identify craters, holes, scouring and the extent of damage. The flooding took out

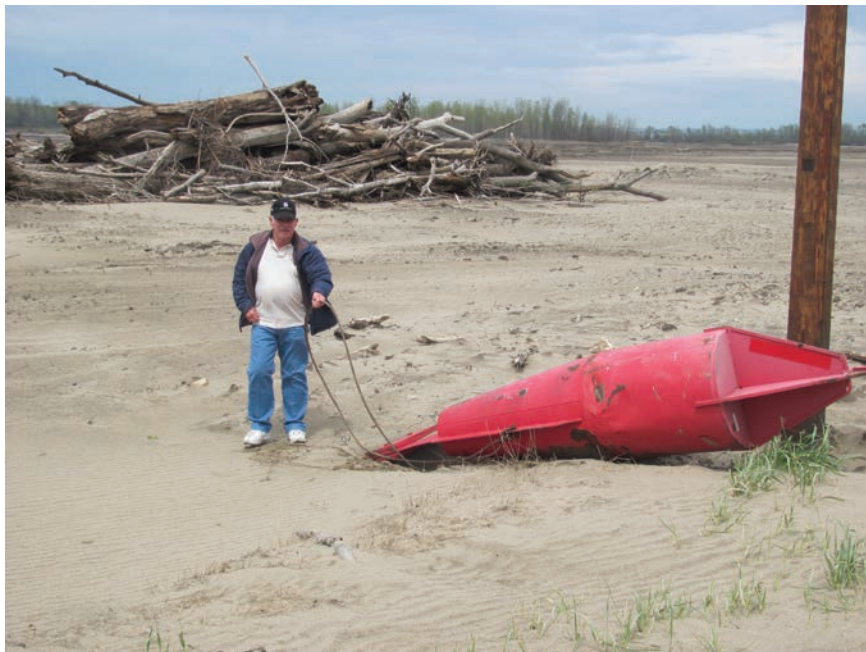
Figure 6

Hundreds of trees were transported by floodwaters and dropped on agricultural lands along with sand and lane line buoys like the red one shown here.

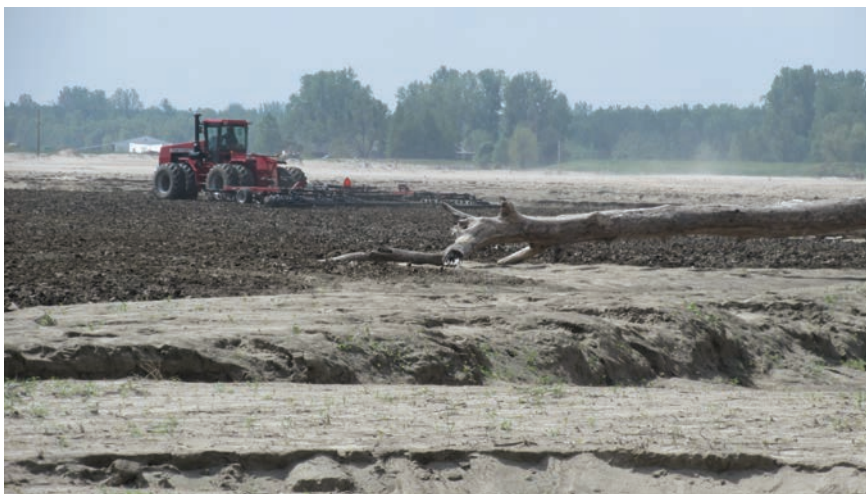
Figure 7

A combination chisel plow and disk is being used to incorporate the sand into the topsoil. The tillage equipment driver attempted to avoid the crater lake, gullies, and land scoured area.

The USACE sonar survey helped the LSLDD to prioritize repairs and target restoration efforts. However local, state, and federal financial resources were limited, and many important repairs were put on hold until resources were available. After farmers, homeowners, and county crews worked to make sure their homes were safe, farmers turned to the spring work of preparing fields for planting. By April some landowners had begun removing the sand from their fields or incorporating it into the topsoil with a combination chisel plow and disk (figure 7). Some soybeans were planted by late April in fields with thin sediment deposits.
