Mississippi River threatens to make Dogtooth Bend peninsula in Illinois an island

Kenneth R. Olson and Lois Wright Morton

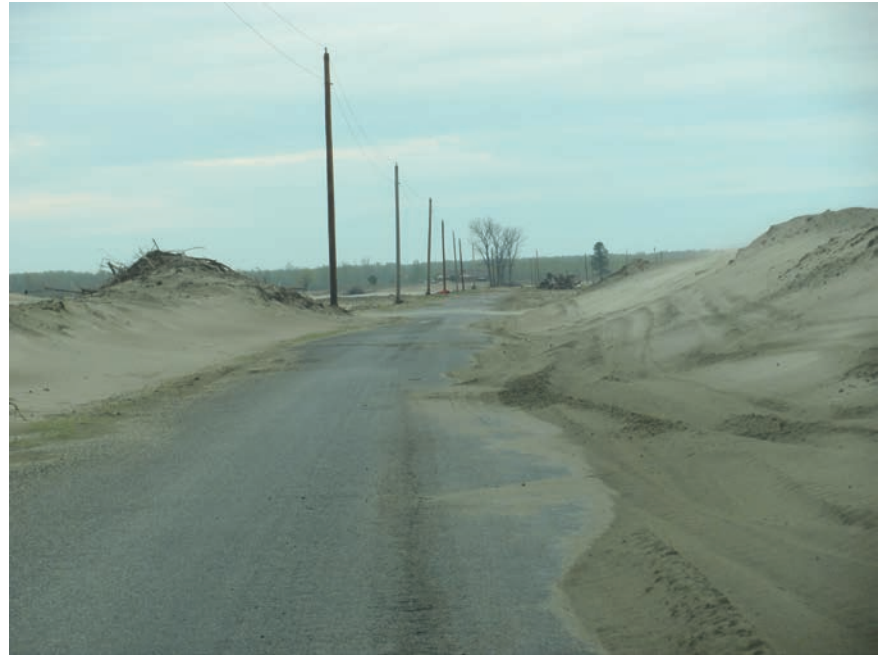
Figure 1

Mississippi River floodwaters deposited many tons of sand on farmland and roads in Dogtooth Bend peninsula when the Len Small levee breached in January of 2016. The sand dunes left behind required graders and snow plows to open the road for local traffic.

the Dogtooth Bend bottomlands along with millions of tons of sand deposited on more than 600 ha (1,500 ac) of farmland. Another 800 ha (2,000 ac) were subjected to land scouring by the Mississippi floodwaters. The county lost 11 to 13 km (7 to 8 mi) of roads with others buried by sand (figure 1). After ditches and culverts filled with sand, drainage was nearly impossible.

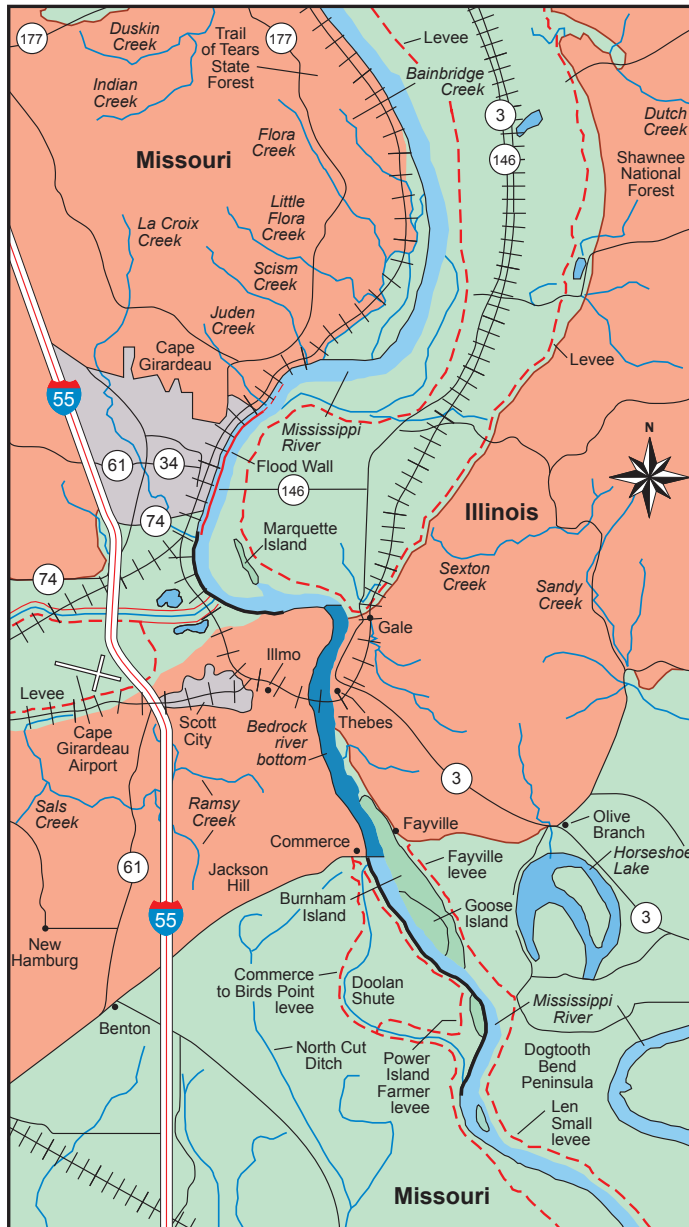
Figure 3

This map shows the location of the Missouri Little River Drainage District diversion channel outlet below Cape Girardeau and the Missouri and Illinois farmer levees south of the Thebes Gap and Commerce, Missouri, which narrowed the original 16 km wide Mississippi River floodplain to less than 2 km.

ing lands around the Big Swamp. The Alexander County, Illinois, bottomland farmers were likely not aware of how the Missouri farmer levees built between 1880 and 1915 (shown in figure 3 by thick black lines on the west side of the river—one south of Cape Girardeau and the other south of Commerce) might affect the Illinois lands on the east side of the Mississippi River.

Gap and south of Cape Girardeau (figure 3) (Olson and Morton 2016a). Prior to the creation of the diversion channel, the Ozark Plateau waters entered the Mississippi River north of Helena, Arkansas, more than 365 river miles to the south (Olson and Morton 2016b). The Little River Headwaters Diversion levee and channel effectively raised the floodwater peaks recorded on the river gages at Cape Girardeau, Missouri; Thebes in Alexander County, Illinois; Cairo, Illinois; and Hickman, Kentucky. New floodwalls and levee systems were built to address threats of urban flooding—Cairo, Illinois, in 1928; the New Madrid Floodway, Missouri, from 1928 to 1932; and Cape Girardeau, Missouri, between

Prior to the construction of the farmer (Len Small–Fayville) levee in Illinois and the farmer (Commerce to Birds Point) levee in Missouri, the Mississippi River was 16 km (10 mi) wide between mile markers 39 to 15 (figure 3). The creation of

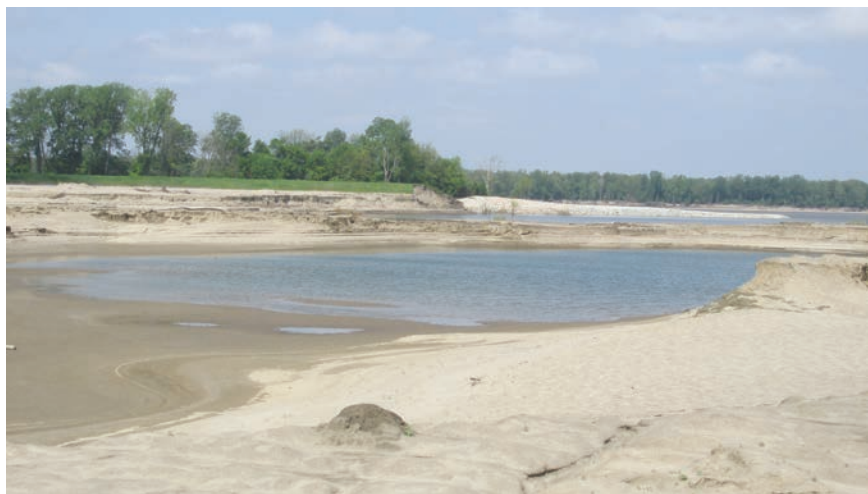
Figure 4

The 2016 Len Small levee breach was 1.6 km long. US Army Corps of Engineer crews, working from barges in the Mississippi River channel, dropped rocks in front of and against levee banks in an attempt to stabilize them. This rock barrier covering a portion of the south end of the levee breach is shown in the right side of picture.

Following the January of 2016 winter flood, the USACE moved a large amount of rock in front of the 1,200 m (4,000 ft) breach (figure 4) in anticipation of spring floods to keep the Mississippi River from extending the 4.6 km (3.5 mi) channel to the next downstream bend in the Mississippi River. If the channel were to permanently cross Dogtooth Bend peninsula, it would become an island cutting off more than 6,000 ha (15,000 ac), at least one hunting structure, and one home from the Illinois mainland. The USACE conducted a sonar survey of the 2016 Len Small levee breach to identify craters, holes, scouring and the extent of damage. The flooding took out

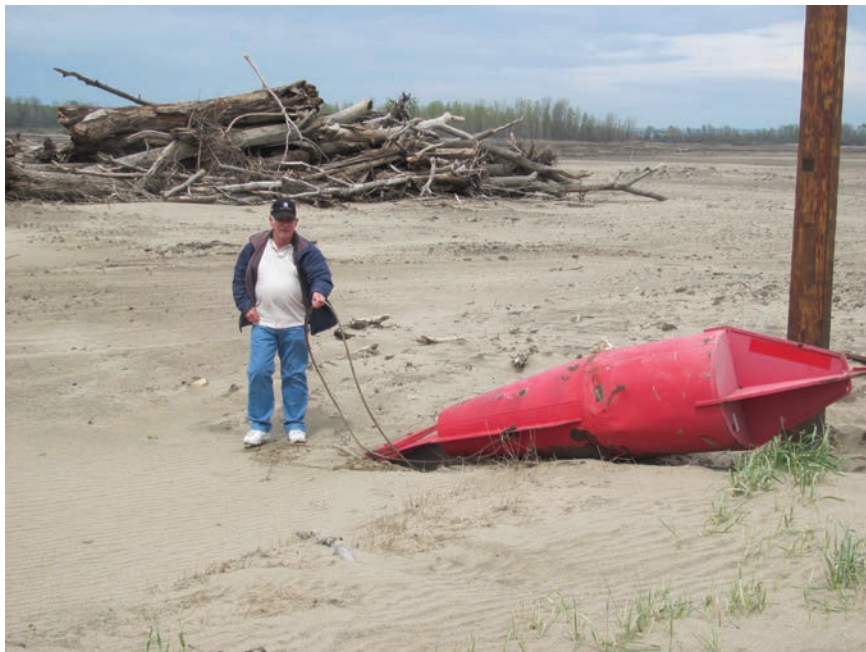
Figure 6

Hundreds of trees were transported by floodwaters and dropped on agricultural lands along with sand and lane line buoys like the red one shown here.

The 2016 Len Small levee breach was much more severe than 2011 because of its location (figure 2). The fast moving river cut a 1.6 km (1 mi) long breach during late December of 2015 through early January of 2016 (figure 4) and scoured out a crater lake and deep gullies into adjacent agricultural lands. The southeast flow of the Mississippi River floodwaters through the breach created a new channel (figure 5) from river mile marker 34 through Alexander County, connected to an old meander channel, and then exited back into the main stem river at mile marker 15, a distance of 4.6 km (3.5 mi). This shortcut across Dogtooth Bend peninsula by-passed about 15 river miles (24 km) of the current Mississippi River path (figure 2). Approximately seven river lane-line buoys, hundreds of trees (figure 6), irrigation pivots, and other debris were carried onto

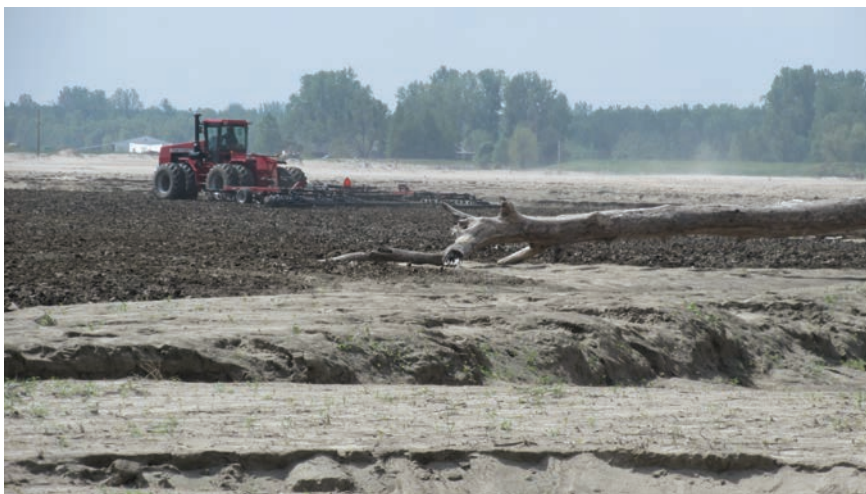
Figure 7

A combination chisel plow and disk is being used to incorporate the sand into the topsoil. The tillage equipment driver attempted to avoid the crater lake, gullies, and land scoured area.

The USACE sonar survey helped the LSLDD to prioritize repairs and target restoration efforts. However local, state, and federal financial resources were limited, and many important repairs were put on hold until resources were available. After farmers, homeowners, and county crews worked to make sure their homes were safe, farmers turned to the spring work of preparing fields for planting. By April some landowners had begun removing the sand from their fields or incorporating it into the topsoil with a combination chisel plow and disk (figure 7). Some soybeans were planted by late April in fields with thin sediment deposits.
